Coastal erosion and mitigation methods – Global state of art

Arkal Vittal Hegde

Department of Applied Mechanics and Hydraulics, National Institute of Technology Karnataka, Surathkal, Mangalore 575 025, India
[E-mail: arkalvittal@gmail.com]

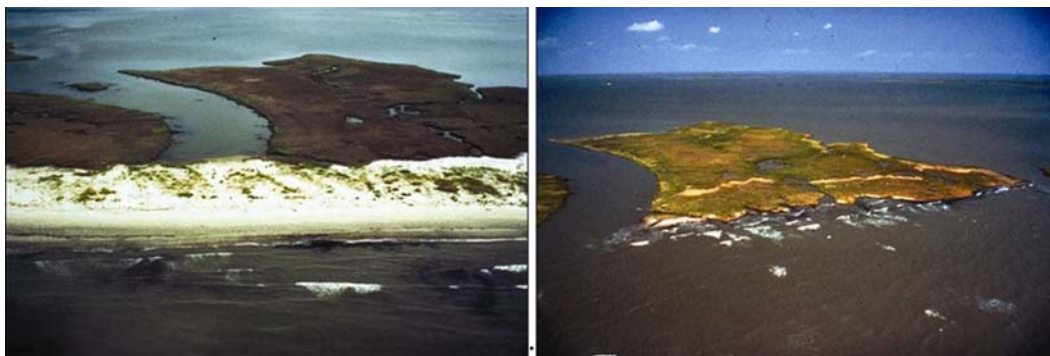
Fig. 1— Part of the Isles Dernieres in central Louisiana before and after passage of Hurricane Andrew in August 1992 (Source: <http://pubs.usgs.gov/fs/hurricane-impacts>).

The images in Figure 1 show part of the Isles Dernieres in central Louisiana before and after sustained winds in excess of 135 miles/hour accompanied Hurricane Andrew, as it passed across the western end of the barrier islands. The photograph on the left was taken in July 1992 before Hurricane Andrew, photograph on the right was taken several days after the passage of Hurricane Andrew in August 1992 (Source: <http://pubs.usgs.gov/fs/hurricane-impacts>). The destruction of the coast is obviously seen in the Figure.

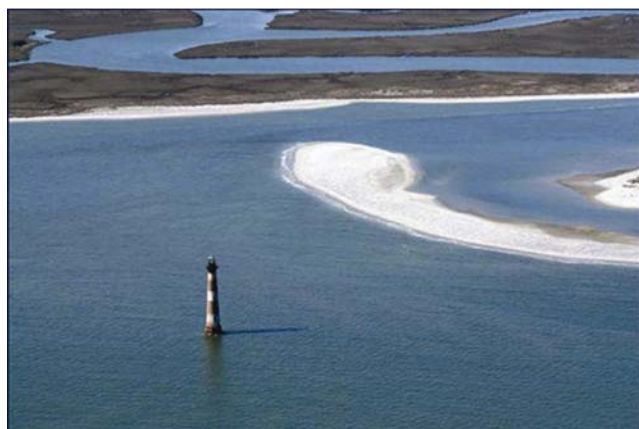
Fig. 2— Morris island light house on land during W.W. II, in Southern California, USA, now inside Sea (Source: <http://www.savethelight.org/gallery200705to200706.html#stayhere>)

Figure 2 shows Morris Island lighthouse initially on land during World War II in Southern California, subsequently inside sea due to heavy erosion. Severe coastal erosion at Maravanthe in Karnataka state of India, where National Highway NH-17 also is threatened by the huge monsoon waves is shown in Figure 3. Subsequently, the shoreline here was strengthened by a seawall.

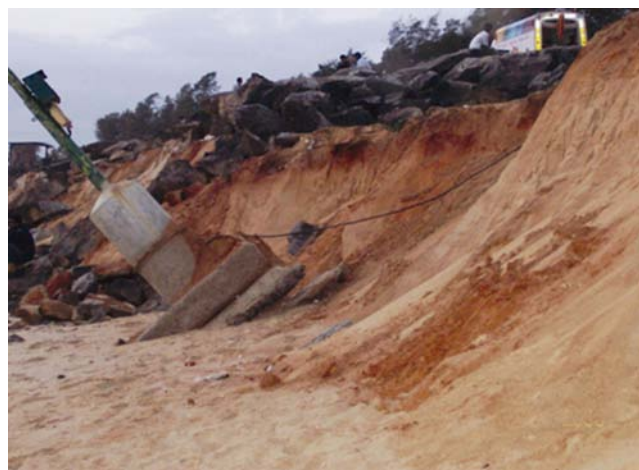
Fig. 3— Severe erosion at Maravanthe beach in Karnataka state of India, threatening NH-17¹².

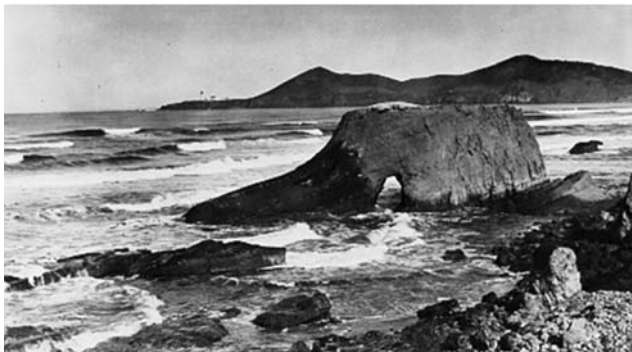
Fig. 4(a) — Sea stack at Nye Beach, Newport, Oregon, USA in 1890 (Source: <http://walrus.wr.usgs.gov/pubinfo/jump.html>).

In New Zealand, in the Queen Charlotte Sound, it is reported that the wake waves formed by the ships and ferry boats plying from ports along the coast, cause erosion of the nearby coast. Figures 4(a) and 4(b) below show the sad demise of a sea stack at Nye Beach, Newport, Oregon, USA from 1890 to 1990 (over a period of 100 years) due to coastal erosion.

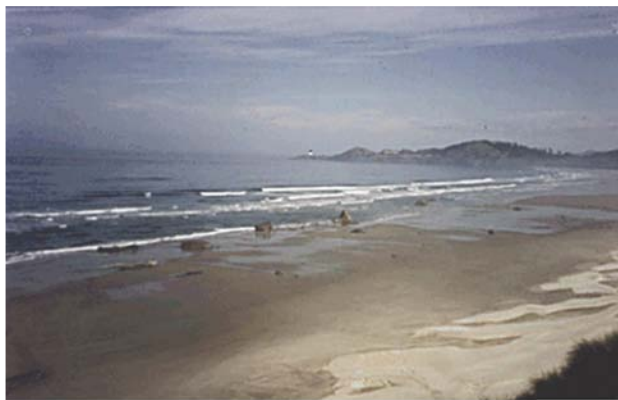
Fig. 4(b) — Almost vanished sea stack at Nye Beach, Newport, Oregon, USA in 1990 (Source: <http://walrus.wr.usgs.gov/pubinfo/jump.html>).

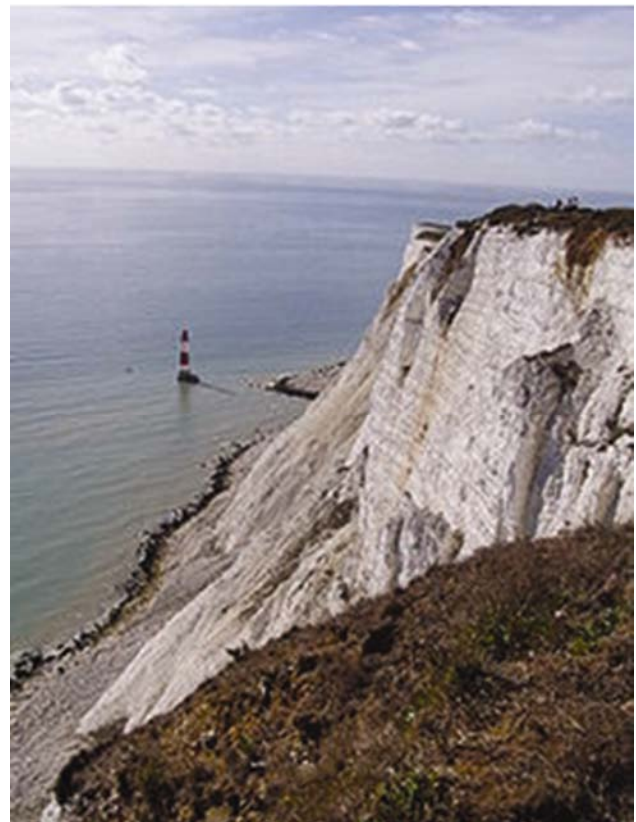
Fig. 5(a) — Cliff erosion in UK (Source: http://en.wikipedia.org/wiki/Beachy_Head).

Figure 5(a) shows a magnificent chalk headland on the south coast of England, in Sussex. The cliff there is the highest chalk sea cliff in sea in Britain, rising to 162 m above MSL, eroded by sea waves. Figure 5(b) portrays the cliff erosion in Massachusetts, USA. The light house inside the sea and the houses on the cliff may be clearly seen.

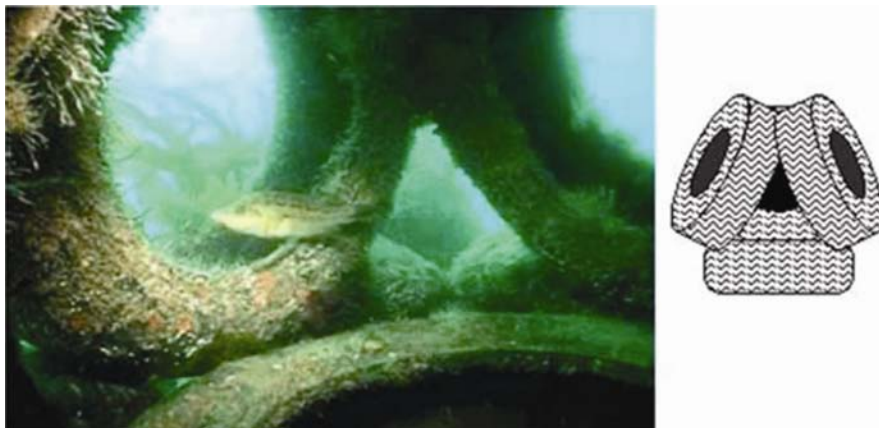
Fig. 9— Tetrahedral design of tyres used in artificial reef in Poole Bay, Dorset, UK (Courtesy of Dr. K.J. Collins; Source: HR Wallingford, UK).

Tetrahedral design of tyres used in artificial reef in Poole Bay, Dorset, UK and Figure 10 depicts a pyramidal bamboo module used in an artificial reef in Philippines.

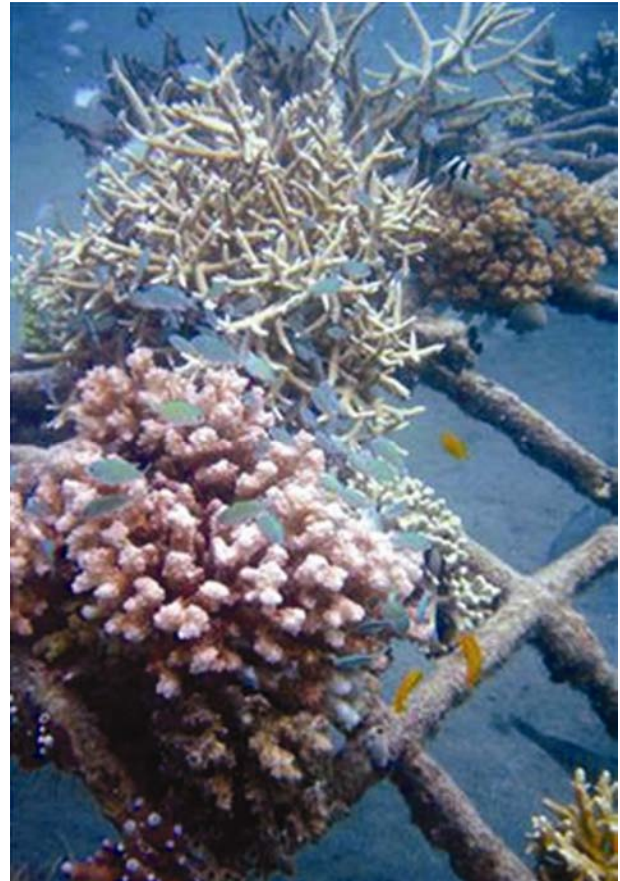
Fig. 11— Rebars used for coral reef development (Source: Wolf Hilbertz/www.globalcoral.org).

In Australia, reefs have been built from materials such as tires and redundant ships. These reefs are used primarily as a focus for recreational angling and SCUBA diving. In Taiwan, many fishing vessels which were made obsolete by government policy to reduce the size of the fishing fleet, were sunk to provide new habitats (<http://www.sbg.ac.at/ipk/avstudio/pierofun/ar/reef.htm>). Figures 11 and 12 show the use of rebars and concrete blocks for artificial reef development.

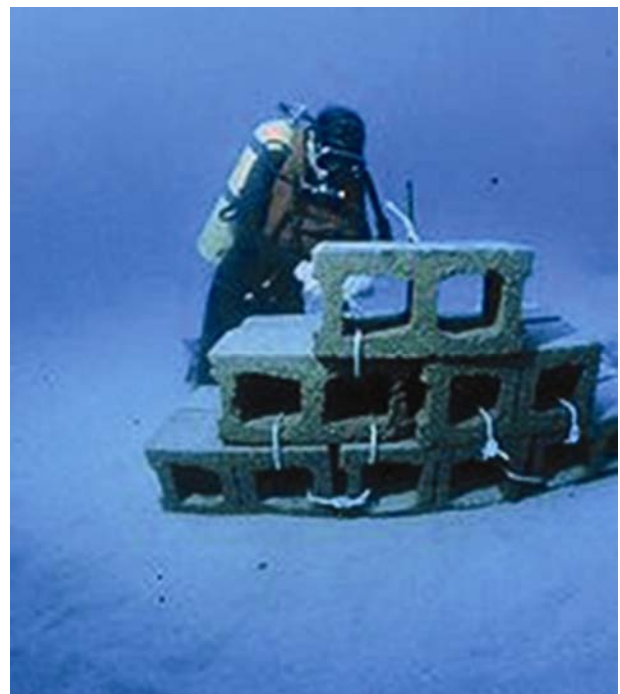
Fig. 12— Artificial reef development using concrete blocks (Source: http://en.wikipedia.org/wiki/Artificial_reef).

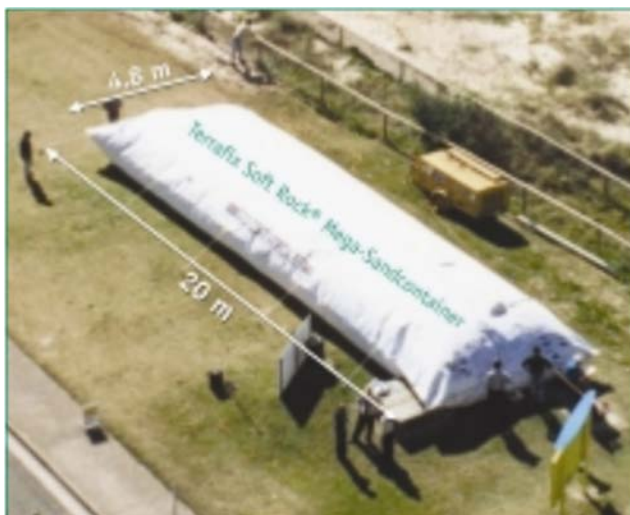
Fig. 13— Terraflx soft rock geotextile sand container (Source: http://www.globalsynthetics.com.au/files/introduction_coastal.pdf).

In Sri Lanka and Australia sand filled non-woven geotextile containers, also called 'soft rock structures', good against abrasion, and having high UV resistance, of 100-250 cu.m size, stable in 8-10 m high waves have been used. Figure 13 shows Terrafix soft rock geotextile sand container. Typically, it could be a 20 m long and 4.8 m wide geotextile sand bag, depending upon site conditions and design parameters. The range of application for these products is extensive and covers areas such as scour protection, groynes, berms, artificial reefs and containment of hazardous materials¹⁷.

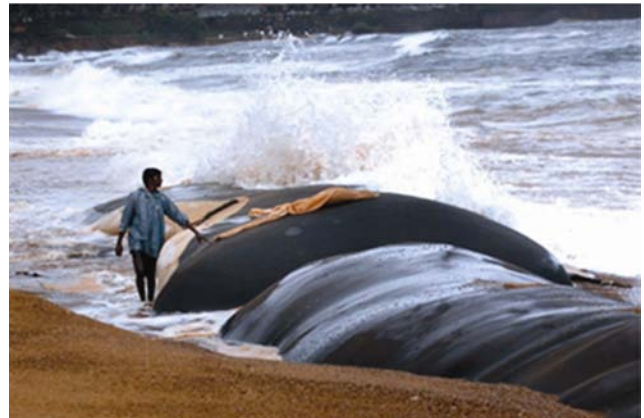
Fig. 14(a) — Geotube used at a beach in Goa (Source: <http://www.goablog.org/posts/coastal-erosion-threatens-goas-idyllic-beaches/>).

Many a times sand containers are used in variants like 'sand sausages' or as 'geotubes', composed of geotextile tubes filled with sand and typically they could be 1 to 2.5 m in diameter. Geotubes have been used in Goa in India recently Figure 14(a). However, it is reported that the 140 m stretch of the geotube at candolim beach has been punctured by floating debris, resulting in further erosion of the devastated beach (Source: <http://www>.

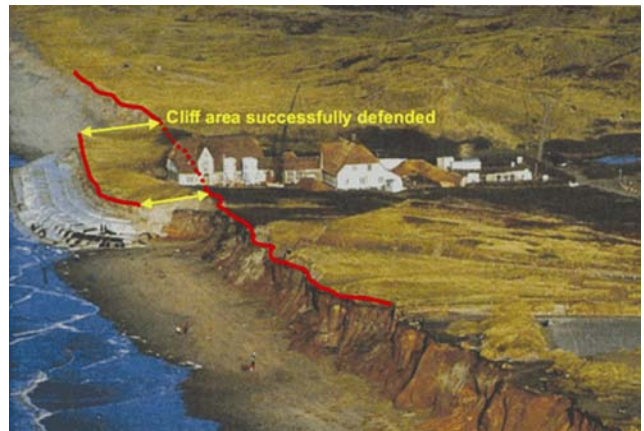
Fig. 14(b) — Defended cliff area with geotextile sand cushions on the Island of Sylt, Germany (Source: <http://www.coastalmanagement.com.au/papers/GeoEng00.pdf>).

In Germany, the historical house “Kliffende” on the Island of Sylt, which was only 5.40 m away from the edge of the cliff, has been defended with geotextile sand cushions. Figure 14(b). The geotextile structure survived storm surges with a still water level at 2.5 m above normal and severe wave action which could reach more than 5.0 m. (Source:<http://www.coastalmanagement.com.au/papers/GeoEng00.pdf>).

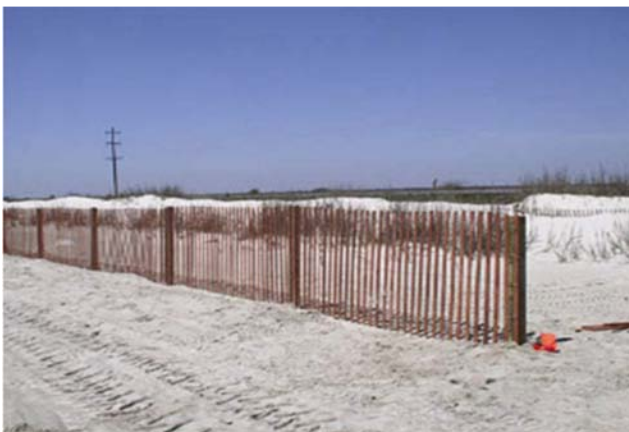
Fig. 15— Sand fencing on an US beach (Source: <http://www.gulfmex.org/crp/7004/fence.jpg>).

When dunes are destroyed by man, disease of beach grass, animal overgrazing etc., re-construction of dunes is possible by this technique, i.e. by driving wooden pickets to about 2 m height, parallel to shoreline at the end of the natural dune line. The porosity of fences could be 50% and the fence fills in

about a year, if good wind is available. Fencing may be raised for another 2 m if required after filling once. This method has been used effectively in US, UK etc, to reconstruct the damaged dunes. See Figure 15 for a typical sand fencing used in US. However, the method needs more time for dune rehabilitation as sand accumulation along the fence is a slow process and depends on the wind velocity, beach slope etc. Hence, it may not be adopted where emergency measures are required to restore the beach.
