STUDIES ON THE ROLE OF HVOF COATINGS TO COMBAT HOT CORROSION, OXIDATION AND EROSION OF MATERIALS USED IN TURBINE COMPONENTS

Thesis

**DEPARTMENT OF METALLURGICAL AND MATERIALS
ENGINEERING**

**NATIONAL INSTITUTE OF TECHNOLOGY KARNATAKA,
SURATHKAL, MANGALORE – 575025**

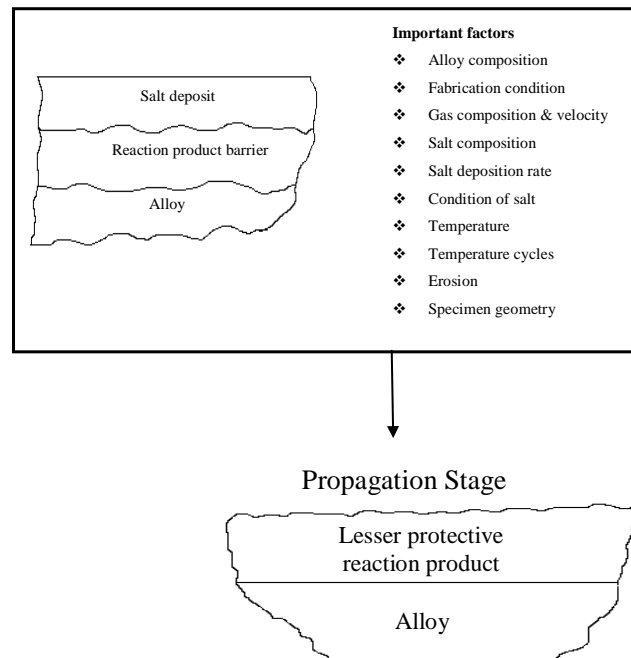
Fig. 2.1 Schematic diagram of hot corrosion mechanisms (Pettit and Meier 1984).

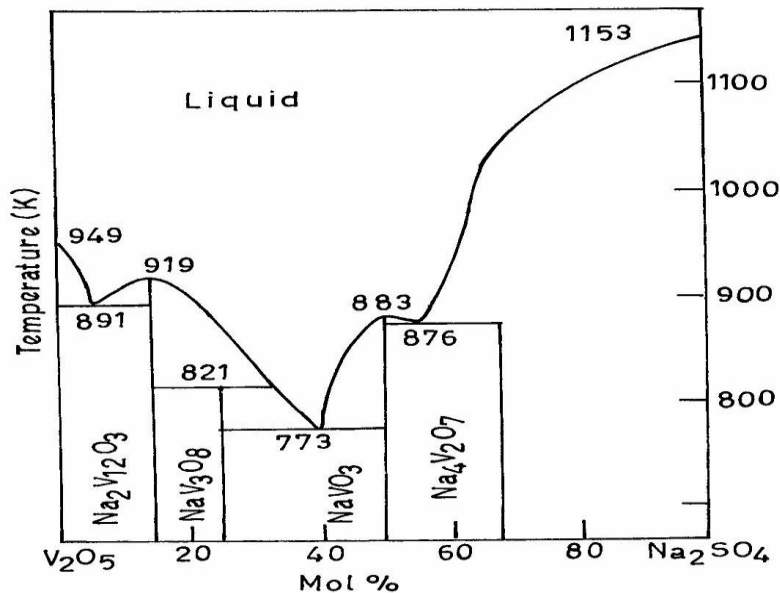
Fig. 2.2 Phase diagram for Na₂SO₄-V₂O₅ system (Otero et al. 1990).

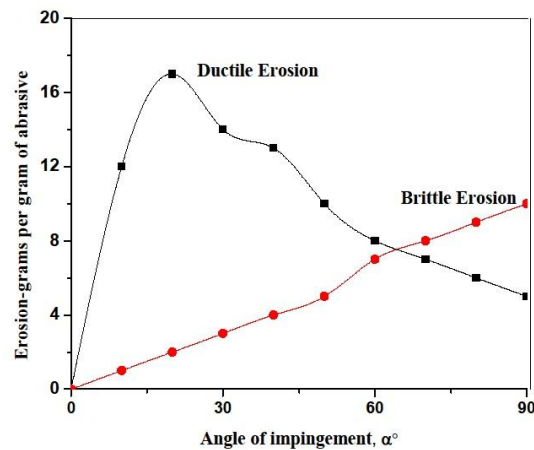
Fig. 2.3 Erosive mass loss as a function of impact angle (Finnie 1972).

response of classical “ductile” and “brittle” materials, which, by virtue of their mechanisms, showed mass loss as a function of impact angle. This response is similar to those in Fig. 2.3. Subsequent work has shown that the material response as a function of impact angle depends on an extensive number of variables, well beyond those related to the material properties.

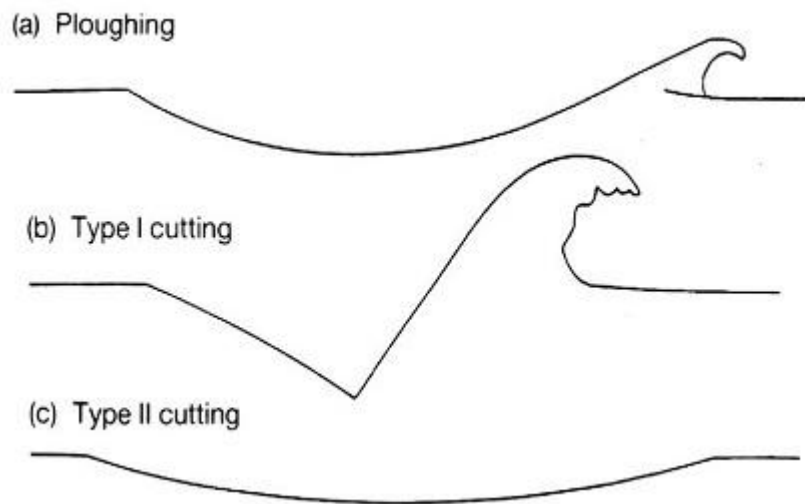
Fig. 2.4 Characteristic mechanisms of ductile erosion based on the variation in erosion conditions (Hutchings 1992).

action during impact, the resulting damage dependent on one of two possible mechanisms. Type I cutting (Hutchings 1992) involves impact by an angular particle in a similar manner to the “ploughing” mechanism of rounded particles.

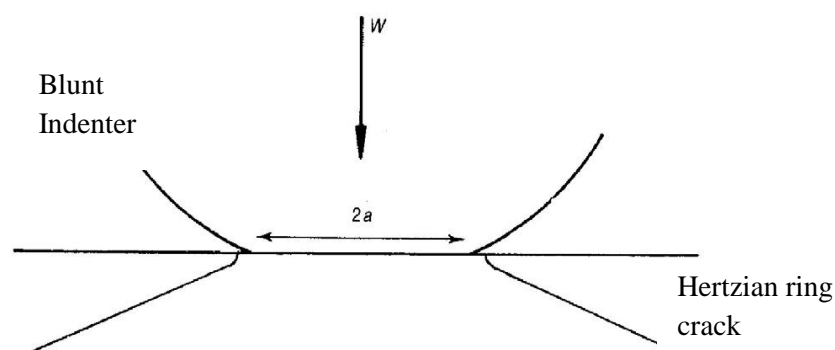
Fig. 2.5 Cross-sectional, schematic view of impact by a blunt indenter on to a brittle material, resulting in the formation of a conical Hertzian crack, (Hutchings 1992).

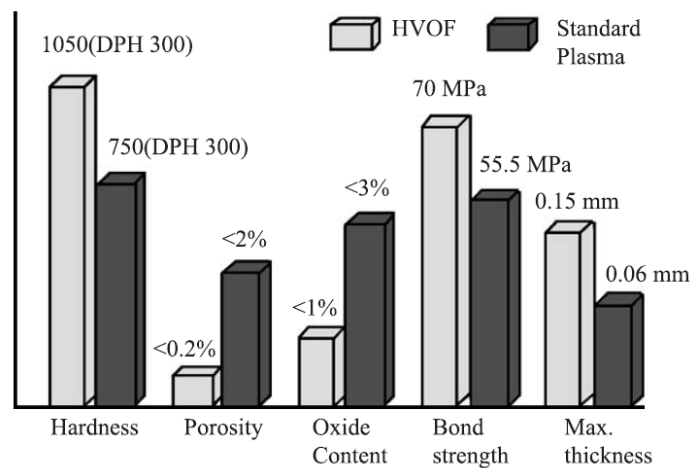
Fig. 2.7 Characteristics of HVOF and standard plasma process coatings (Helali and Hashmi 1996).

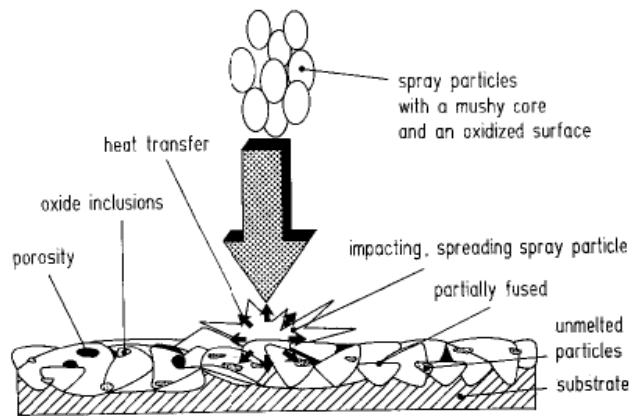
Fig. 2.8 Schematic of a typical structure of sprayed coating (Bunshah 2001)

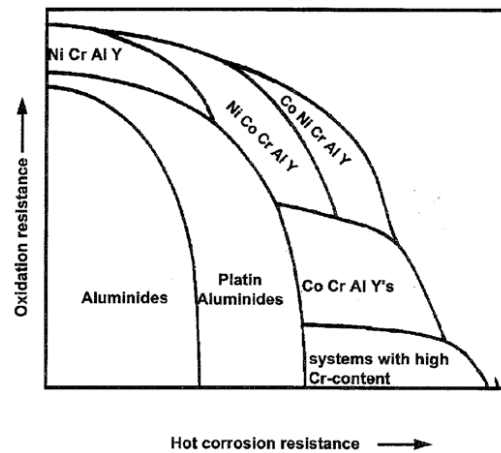
Fig. 2.11 Corrosion and oxidation resistance of different types of coatings. (Nicholls and Rickerbery 2002)

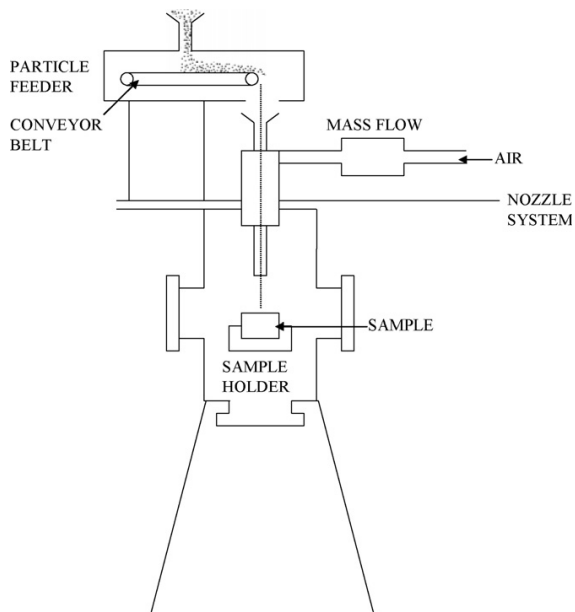
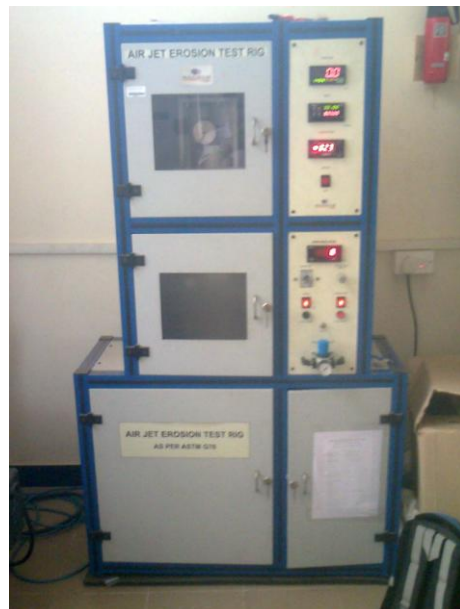
Fig. 3.2 Schematic view of an air jet erosion test rig.

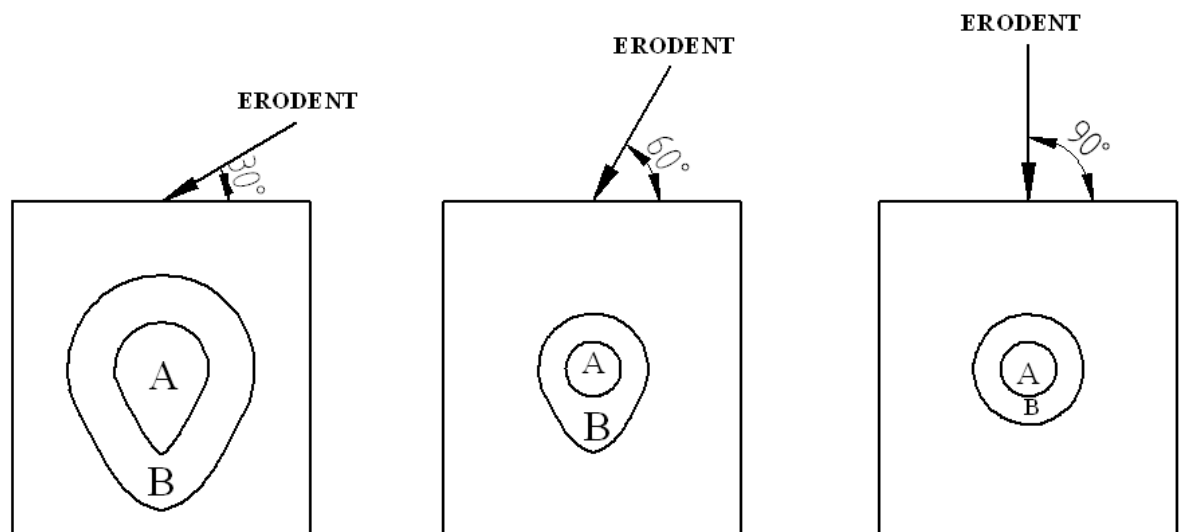
Fig. 3.4 Schematic diagram of the erosion scar produced on the eroded surface at an impact angle of 30°, 60° and 90°.

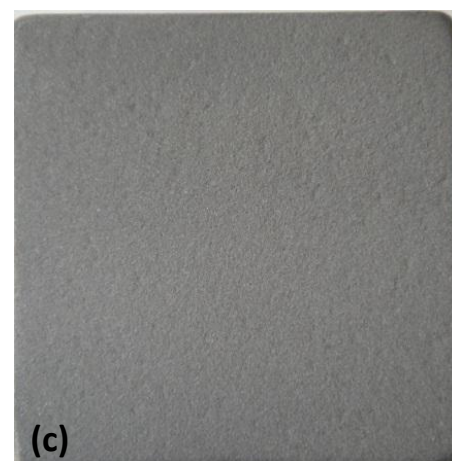
Fig. 4.5 Optical macrograph of 25%(Cr₃C₂-25(Ni₂₀Cr)) + 75%NiCrAlY coated materials. Sample size is 25 mm X 25 mm (a) Ti-31 (b) Superco-605 (c) MDN-121

The optical macrograph of substrate materials, over a size of 25 mm X 25 mm are shown in Fig. 4.3, for the purpose of comparison. The optical macrographs of the as-sprayed samples are shown in Figs. 4.4, 4.5 and 4.6. In each case a, b, c corresponds to substrate materials Ti-31, Superco-605 and MDN-121 respectively. The coatings are free from surface cracks. The colour of the as-sprayed oxide alloy (10% $\text{Al}_2\text{O}_3+\text{CoCrAlTaY}$) coating (Fig. 4.4), carbide alloy (25% Cr_3C_2 -25(Ni20Cr) +NiCrAlY) coating (Fig. 4.5) and Stellite-6 coating (Fig. 4.6) is dark grey. The measured surface roughness value for the oxide alloy (10% $\text{Al}_2\text{O}_3+\text{CoCrAlTaY}$), carbide alloy (25% Cr_3C_2 -25(Ni20Cr) +75%NiCrAlY) and Stellite-6 coatings are found to be 4.13 μm 7.67 μm and 10.1 μm , respectively. Average value of 10 readings is reported as the roughness value (Ra) and reported in Table 4.2.

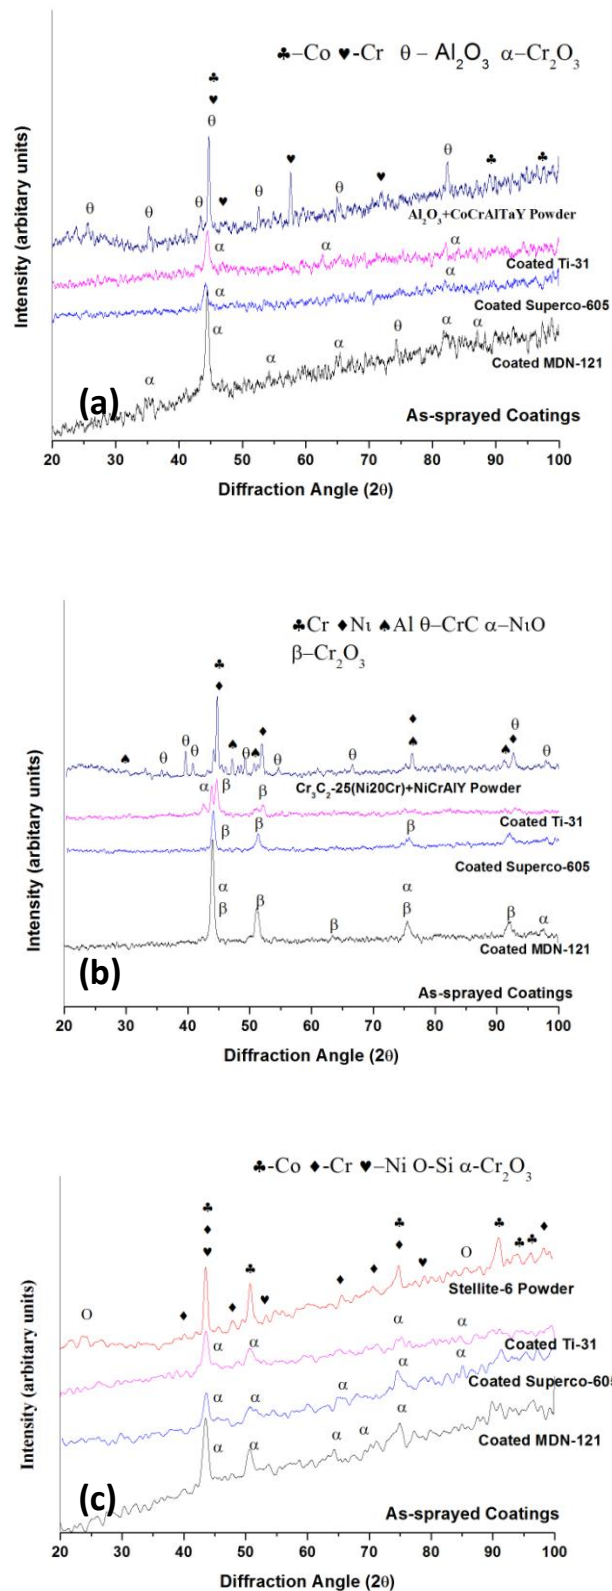
Fig. 4.10 X-ray diffraction patterns for powder and as-sprayed coatings
(a) 10% $\text{Al}_2\text{O}_3 + \text{CoCrAlTaY}$ (b) 25% $(\text{Cr}_3\text{C}_2\text{-}25(\text{Ni}_{20}\text{Cr})) + 75\% \text{NiCrAlY}$
(c) Stellite-6

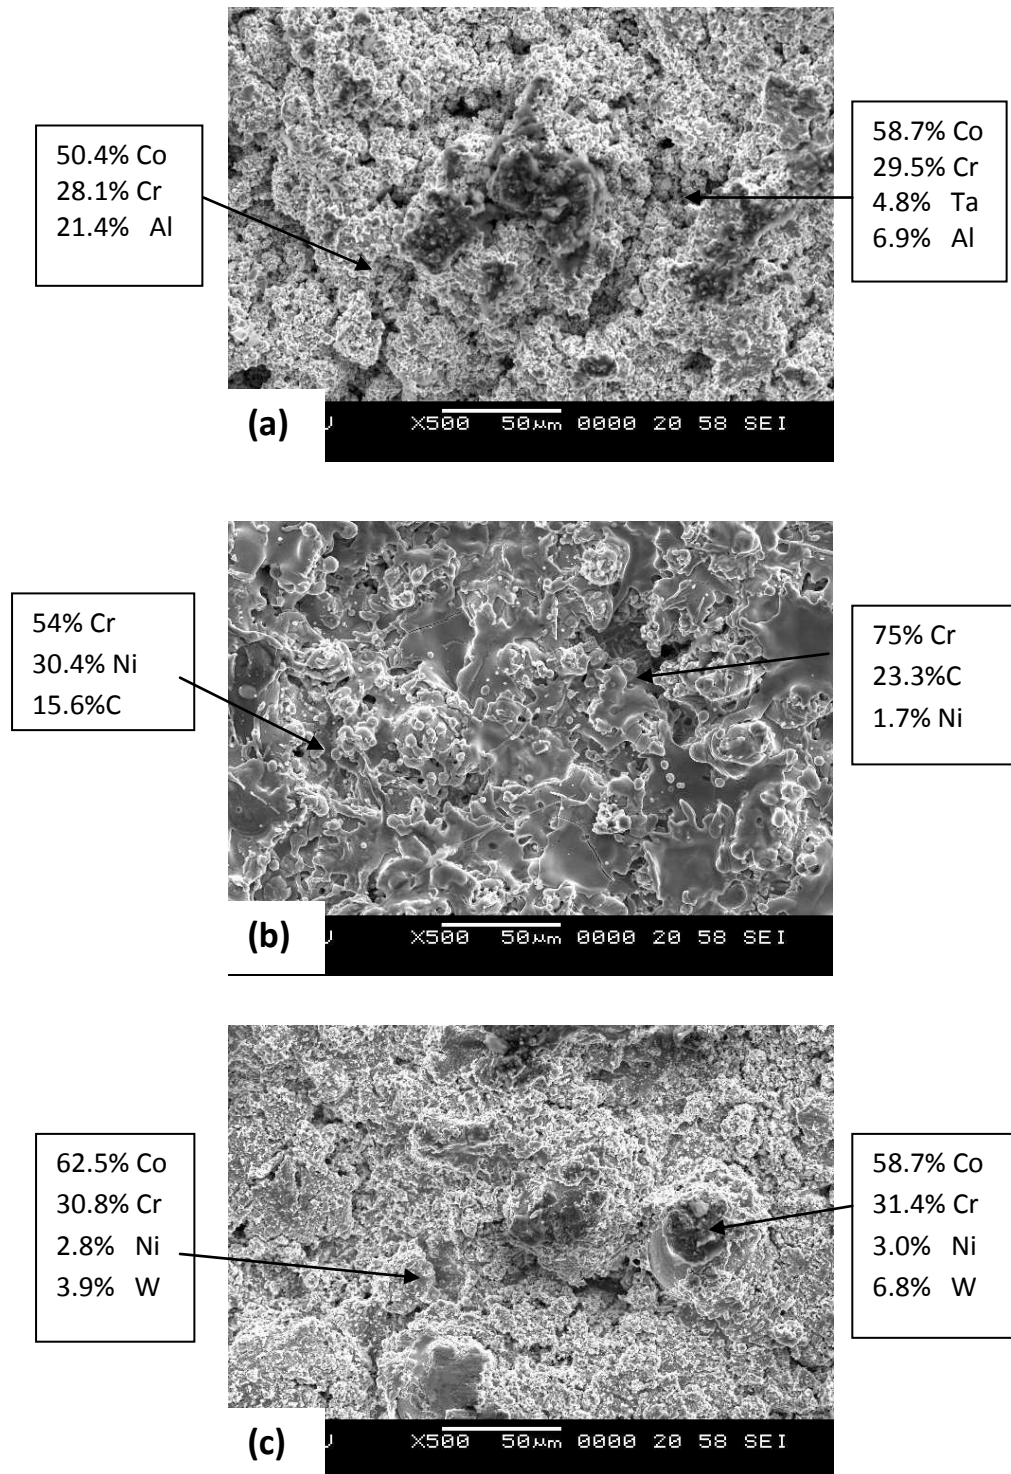
Fig. 4.11 SEM/EDX analysis on surface of as-sprayed coating showing coating morphology and elemental composition (wt. %) at selected points in the coating (a) 10% Al_2O_3 +CoCrAlTaY (b) 25% $(\text{Cr}_3\text{C}_2$ -25(Ni20Cr))+75% NiCrAlY (c) Stellite-6

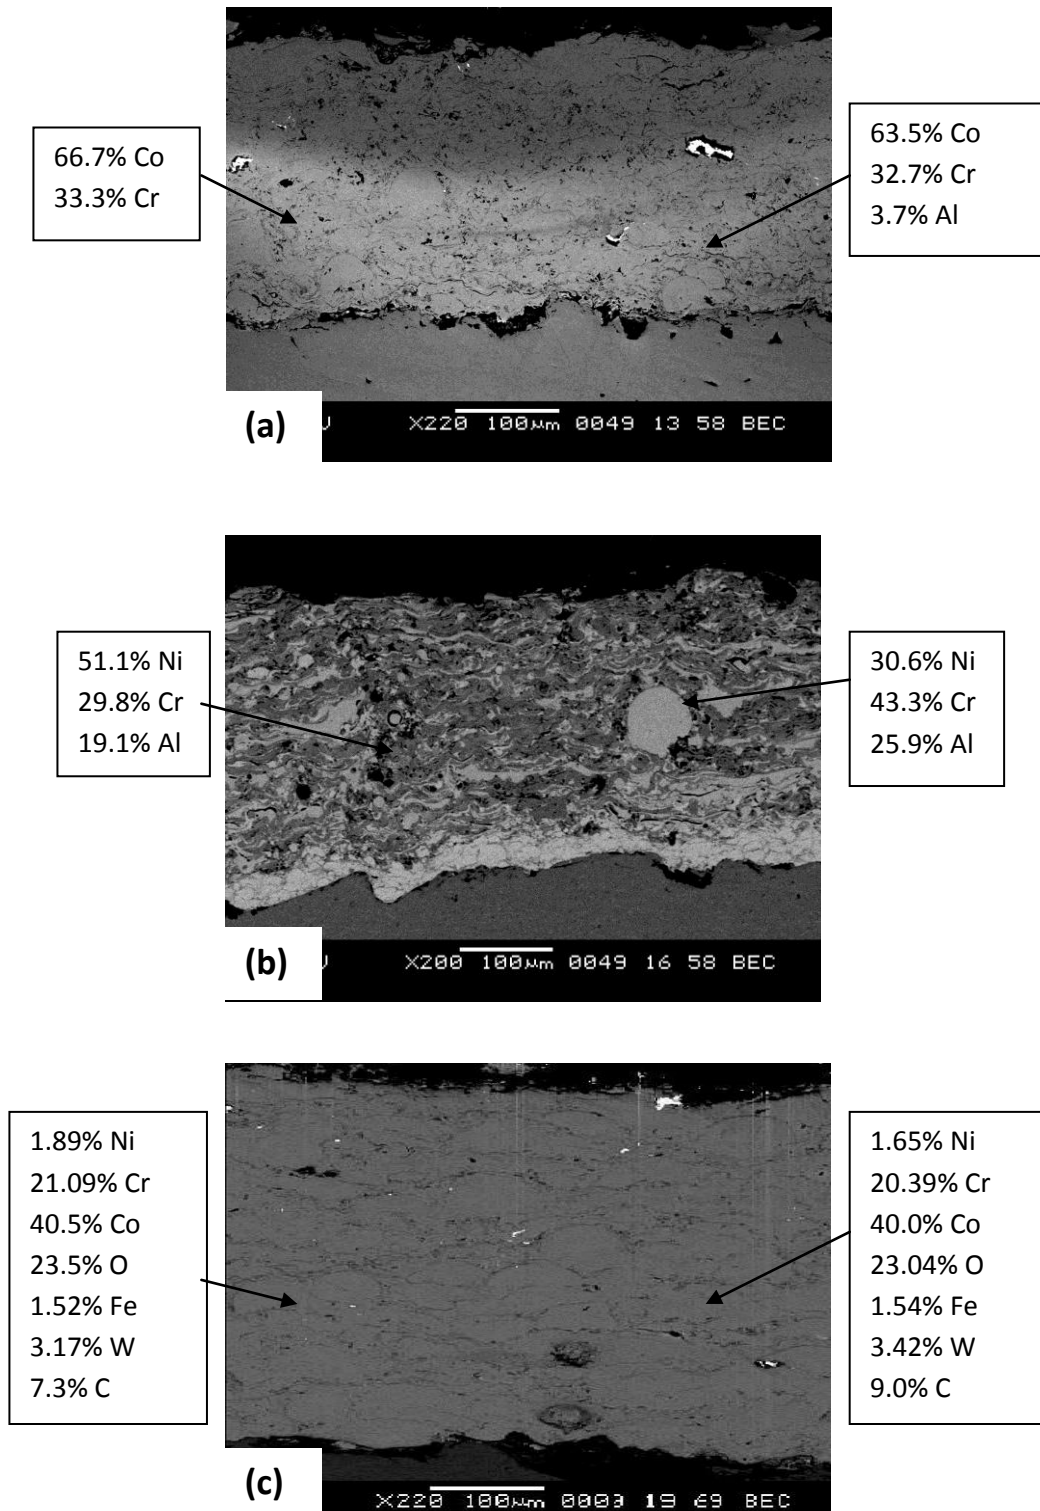
Fig. 4.12 Back scattered electron micrograph and EDX analysis (wt%) across the cross-section of the as-sprayed coatings: (a) 10%Al₂O₃+CoCrAlTaY (b) 25% (Cr₃C₂-25(Ni20Cr))+75%NiCrAlY (c) Stellite-6

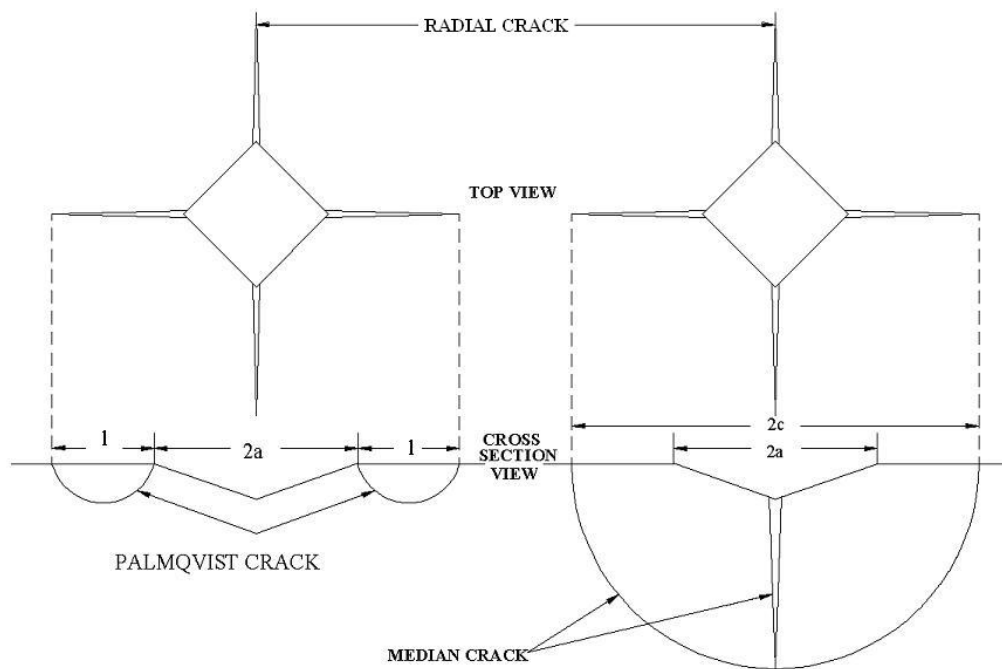
Fig. 4.13 Comparison of geometries of Palmqvist and median cracks around Vickers indentation (Niihara 1983).

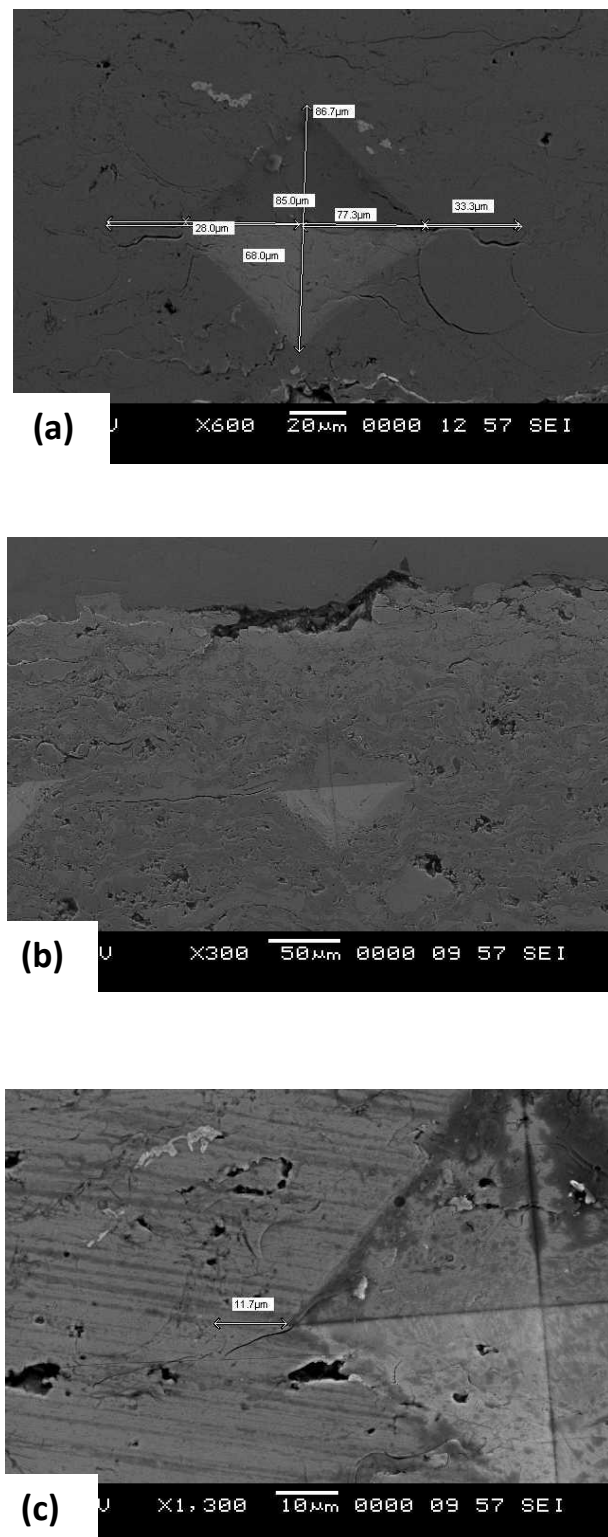
Fig. 4.14 Back scattered electron image of indentation on the as-sprayed coatings: (a) 10%Al₂O₃+CoCrAlTaY (b) 25% (Cr₃C₂-25(Ni₂₀Cr)) +75% NiCrAlY (c) Stellite-6.

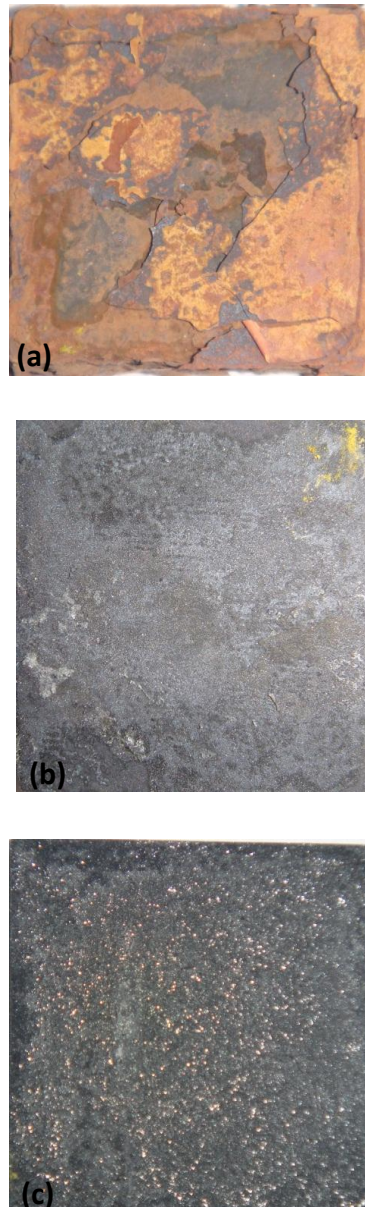
Fig. 5.1 Macrograph of uncoated samples (25mm X 25mm X 5 mm) after 50 cycles of hot corrosion under Na_2SO_4 -50wt% V_2O_5 salt environment at 800 °C (a) Ti-31 (b) Superco-605 (c) MDN- 121.

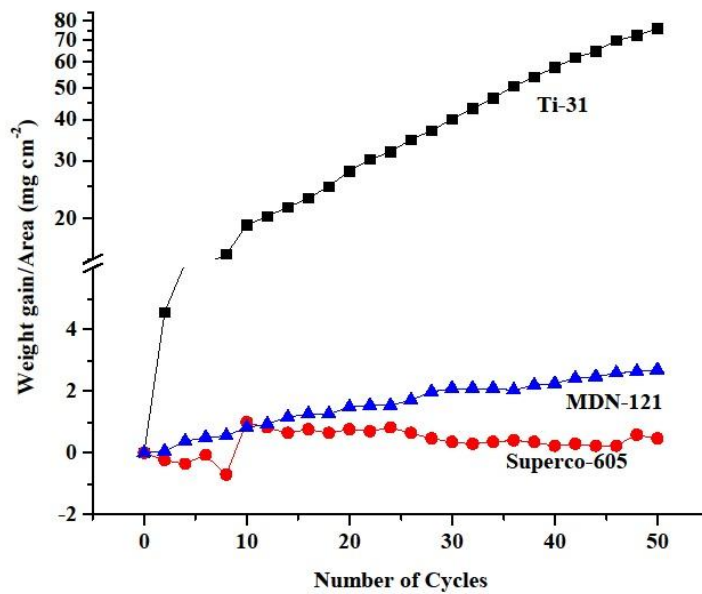
Fig. 5.2 Plot of weight gain/area versus number of cycles for uncoated samples subjected to hot corrosion.

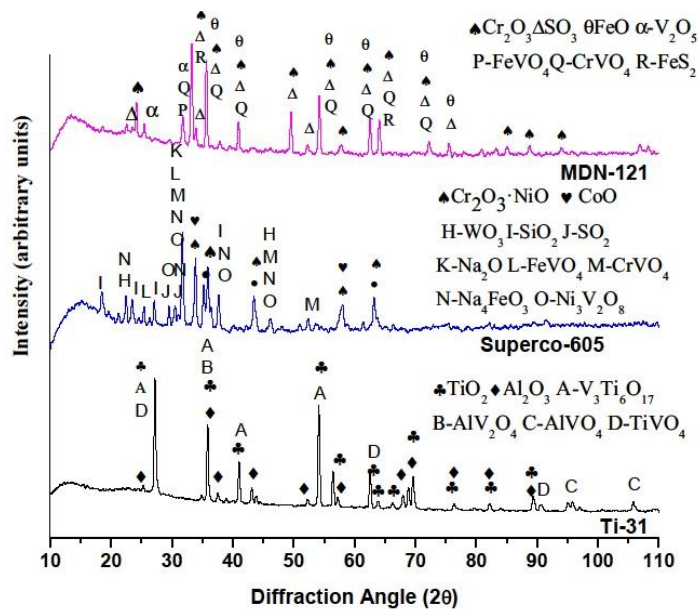
Fig. 5.3 X-ray diffraction patterns for uncoated substrate materials subjected to hot corrosion in Na₂SO₄-50% V₂O₅ for 50 cycles at 800 °C.

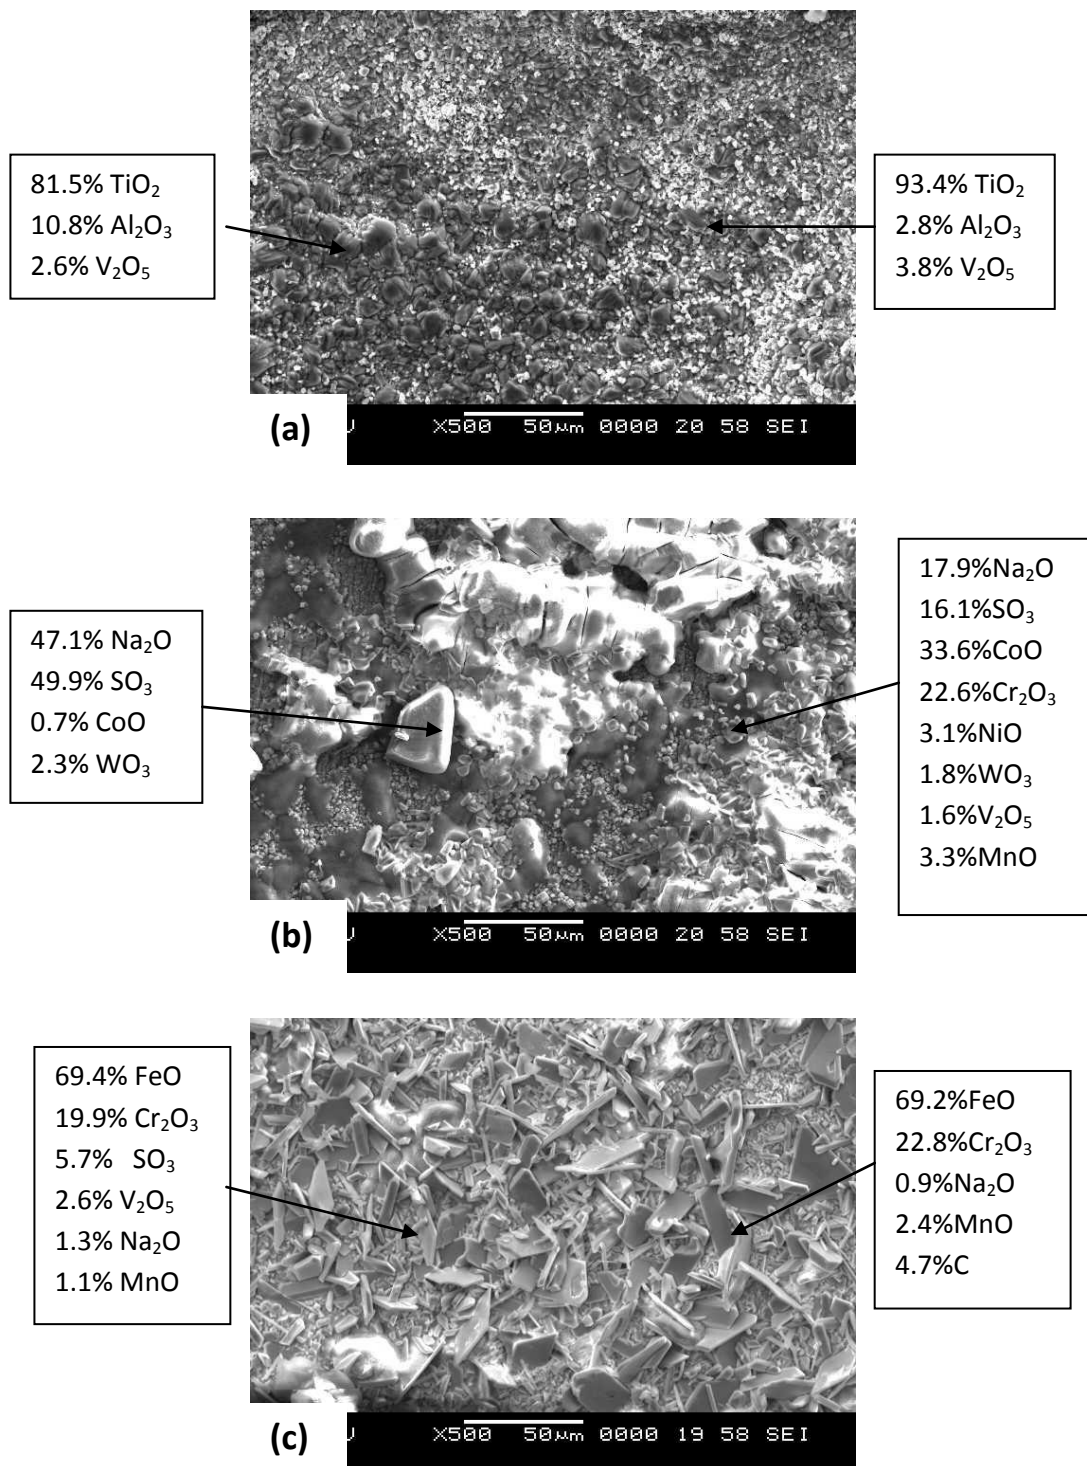
Fig. 5.4 SEM/EDX analysis for uncoated substrate materials subjected to hot corrosion for 50 cycles in $\text{Na}_2\text{SO}_4+50\%\text{V}_2\text{O}_5$ at 800 °C (a) Ti-31 (b) Supercor-605 (c) MDN-121.

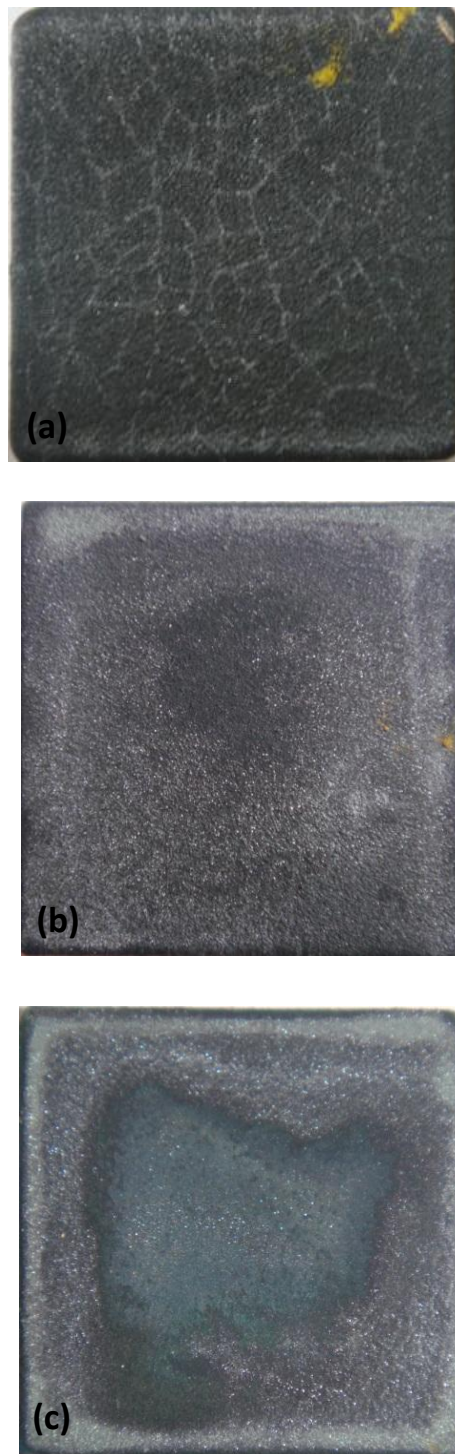
Fig. 5.5 Macrographs of 10% $\text{Al}_2\text{O}_3+\text{CoCrAlTaY}$ coating (25mm X 25mm X 5 mm) subjected to hot corrosion in $\text{Na}_2\text{SO}_4-50\%\text{V}_2\text{O}_5$ environment at 800 °C for 50 cycles (a) Ti-31 (b) Superco-605 (c) MDN-121.

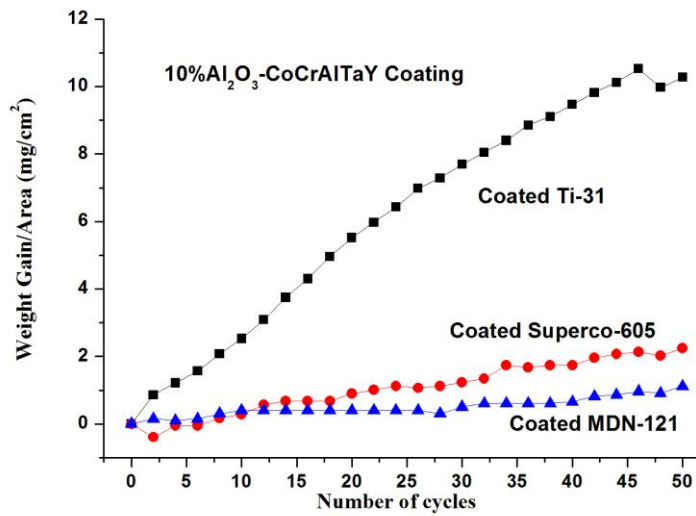
Fig. 5.6 Plot of weight change versus number of cycles for 10% Al₂O₃ + CoCrAlTaY coated materials subjected to hot corrosion in Na₂SO₄-50%V₂O₅ salt environment at 800 °C.

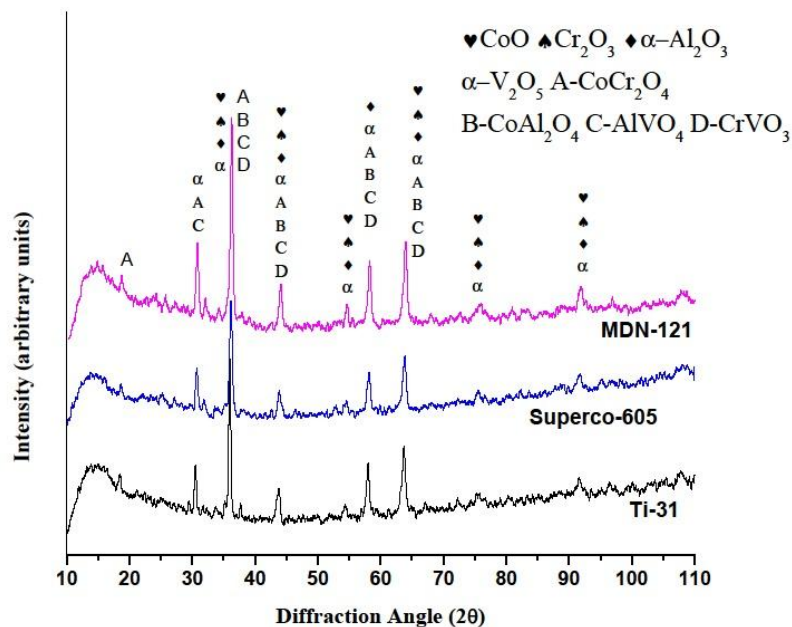
Fig. 5.7 X-ray diffraction patterns for 10% Al₂O₃+CoCrAlTaY coated Ti-31, Superco-605 and MDN-121 subjected to hot corrosion in Na₂SO₄-50%V₂O₅ at 800 °C

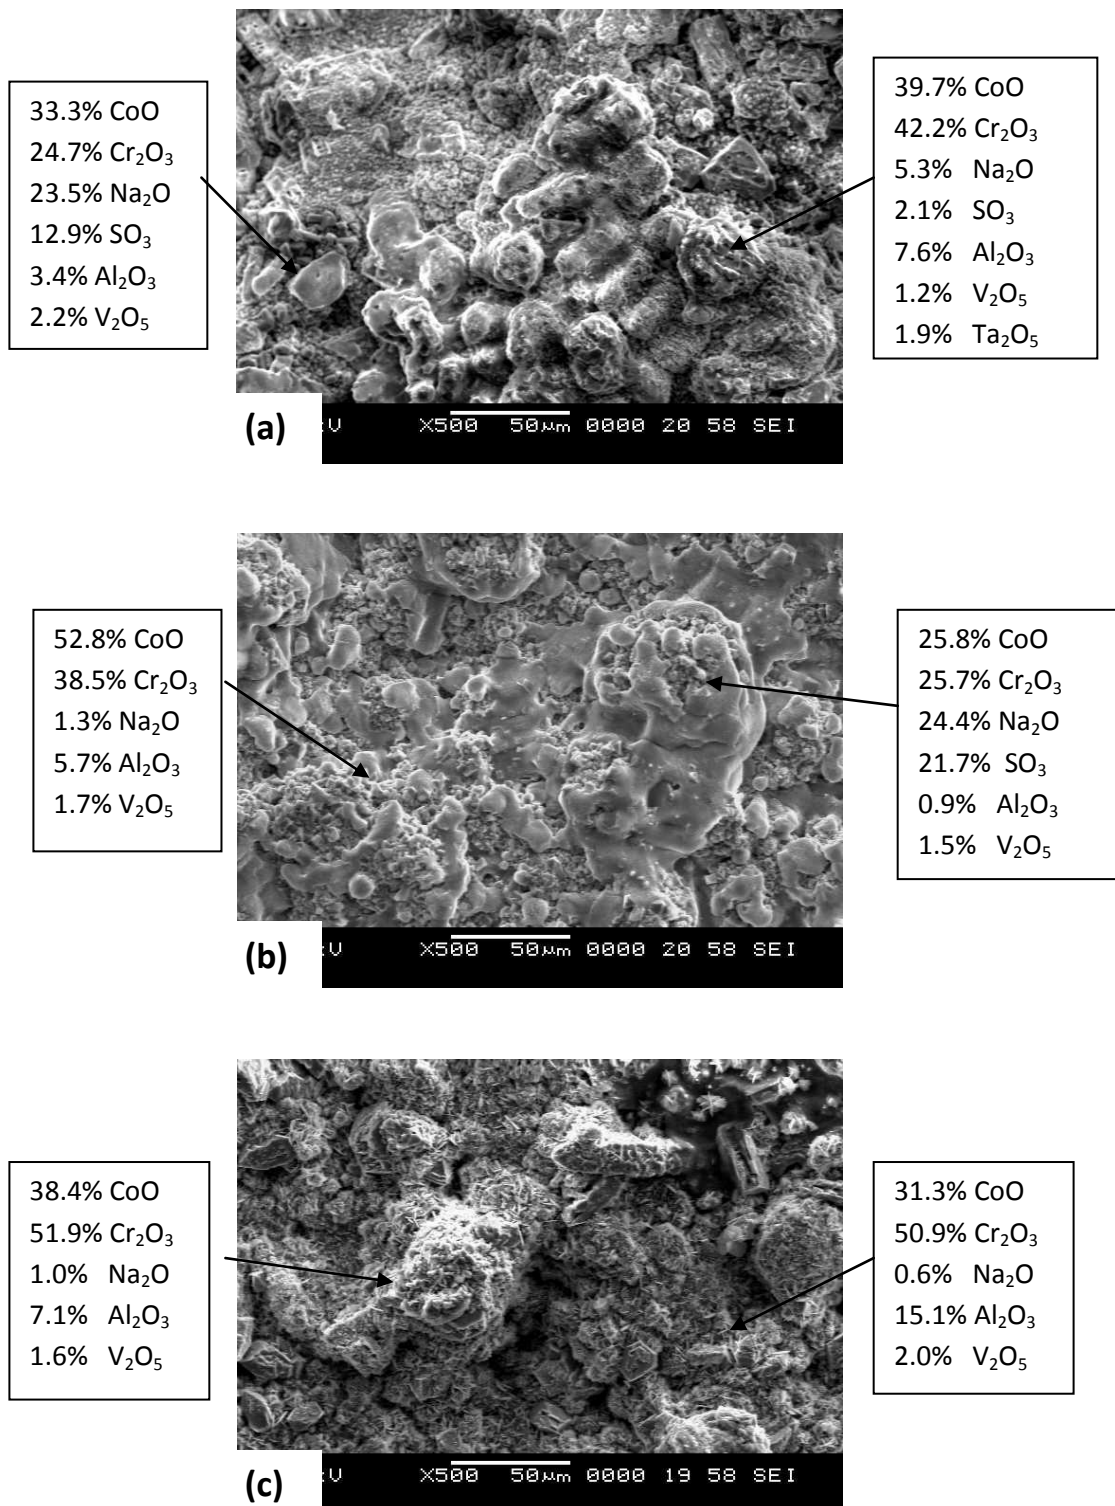
Fig. 5.8 SEM/EDX point analysis for 10% Al₂O₃+CoCrAlTaY coated samples subjected to hot corrosion in Na₂SO₄+50%V₂O₅ at 800 °C (a)Ti-31 (b) Superco-605 (c) MDN- 121.

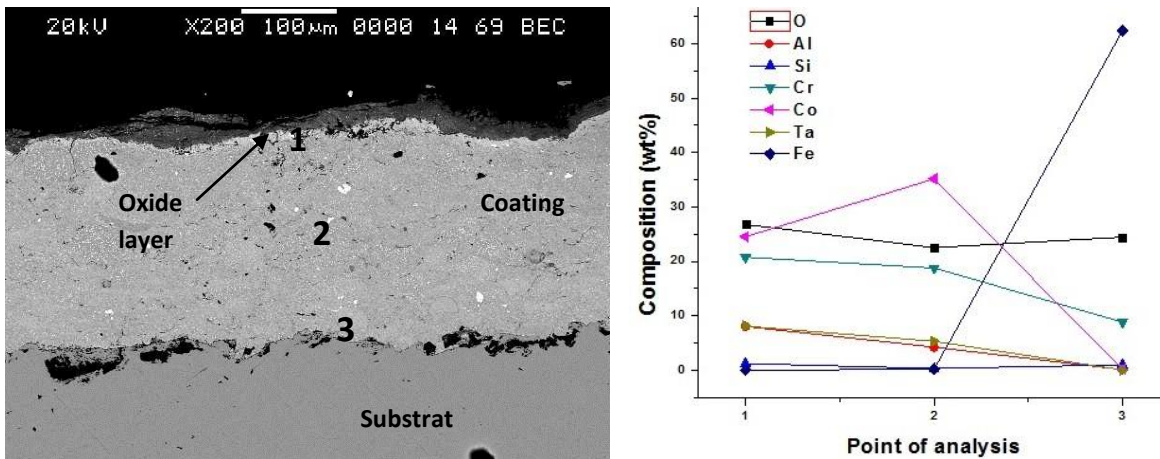
Fig. 5.9 Back scattered image and EDX analysis of across the cross-section of the 10% Al_2O_3 +CoCrAlTaY coated MDN-121 material subjected to hot corrosion for 50 cycles in Na_2SO_4 +50% V_2O_5 at 800 °C.

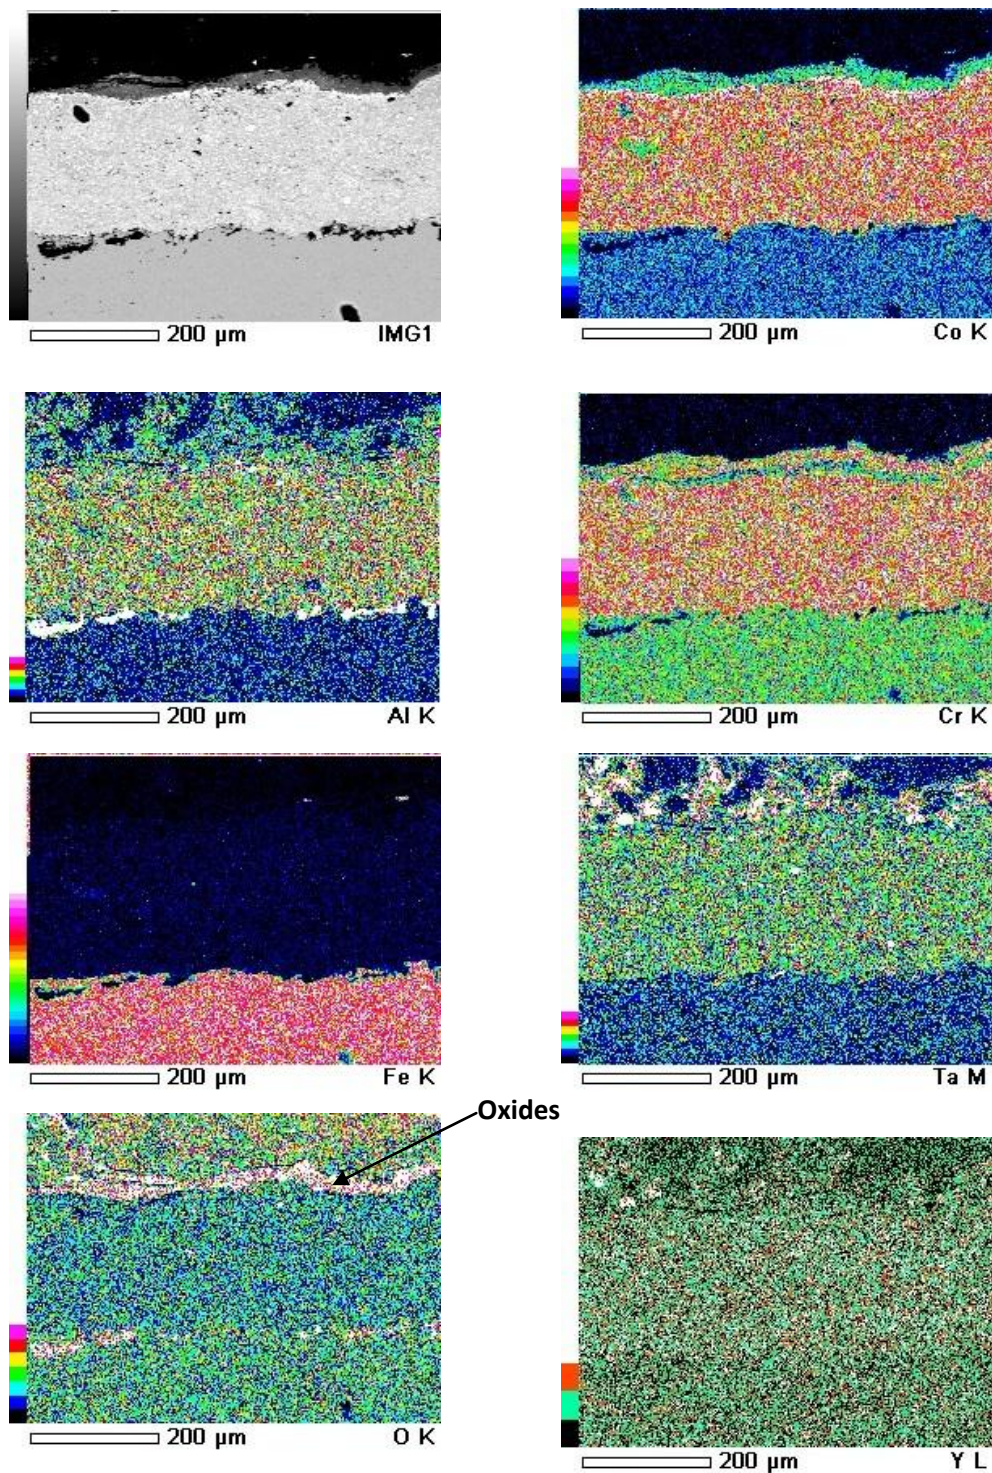
Fig. 5.10 X-ray mapping along the cross-section of the 10% Al_2O_3 +CoCrAlTaY coated MDN-121 material subjected to hot corrosion for 50 cycles in Na_2SO_4 + 50% V_2O_5 environment at 800 °C.

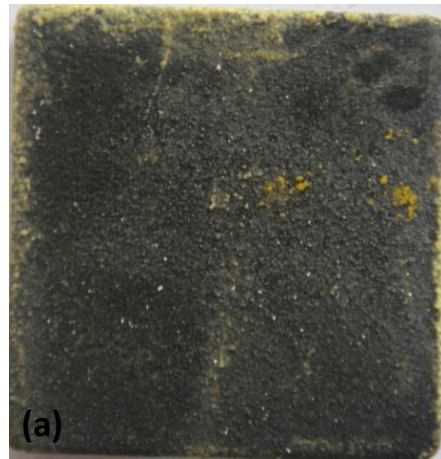
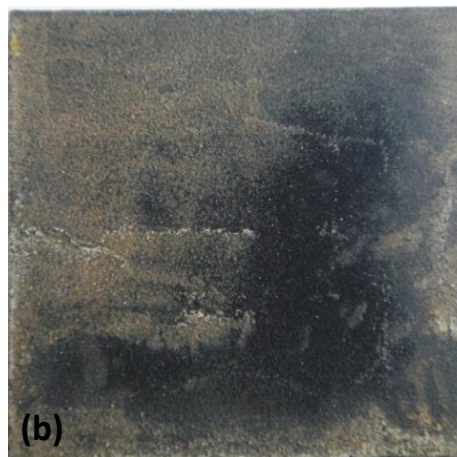
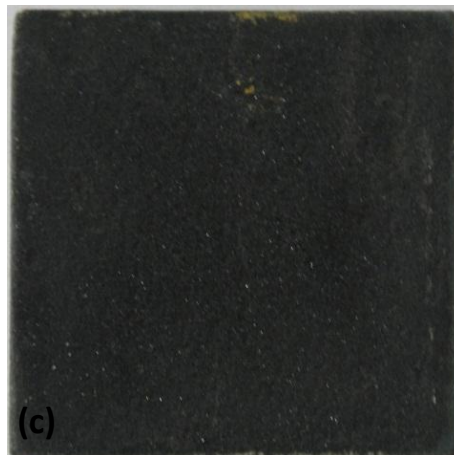
Fig. 5.11 Macrographs of 25% (Cr_3C_2 -25(Ni20Cr)) + 75% NiCrAlY coating (25mm X 25mm X 5mm) subjected to hot corrosion in Na_2SO_4 -50% V_2O_5 environment at 800 °C for 50 cycles (a) Ti-31 (b) Superco-605 (c) MDN-121.

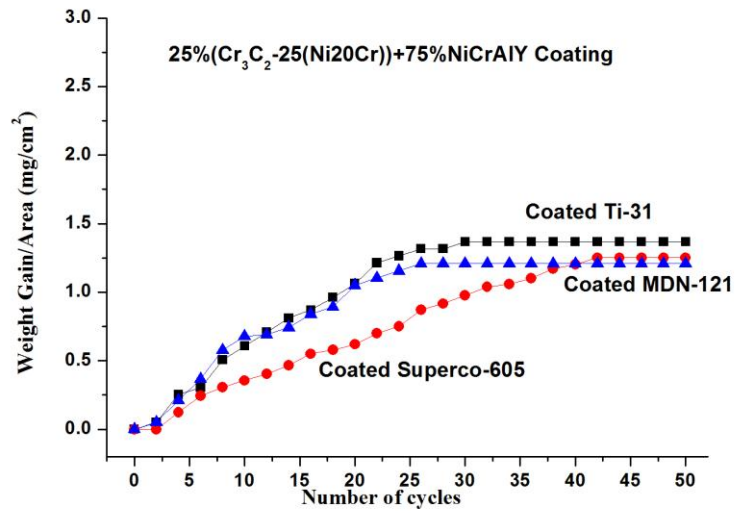
Fig. 5.12 Plot of weight gain/area versus number of cycles for 25% (Cr_3C_2 -25(Ni20Cr)) + 75% NiCrAlY coated samples subjected to hot corrosion.

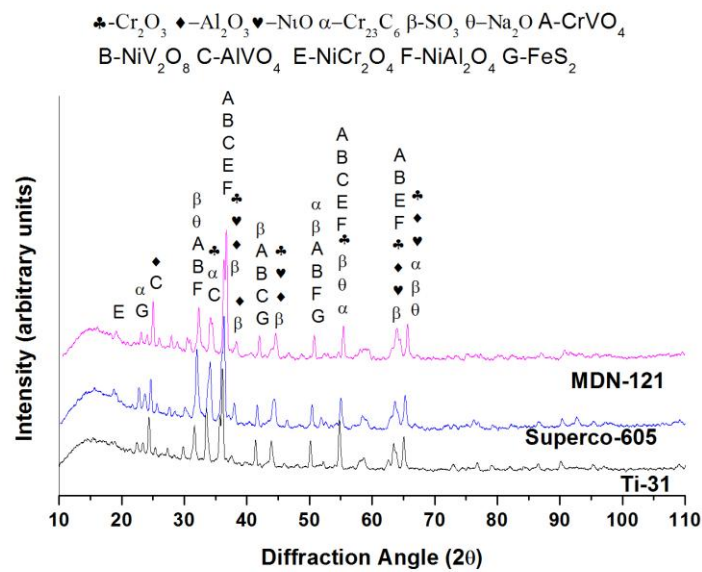
Fig. 5.13 X-ray diffraction patterns for 25% (Cr_3C_2 -25(Ni20Cr)) + 75%NiCrAlY coated Ti-31, Superco-605 and MDN-121 subjected to hot corrosion in Na_2SO_4 -50% V_2O_5 for 50 cycles at 800 °C.

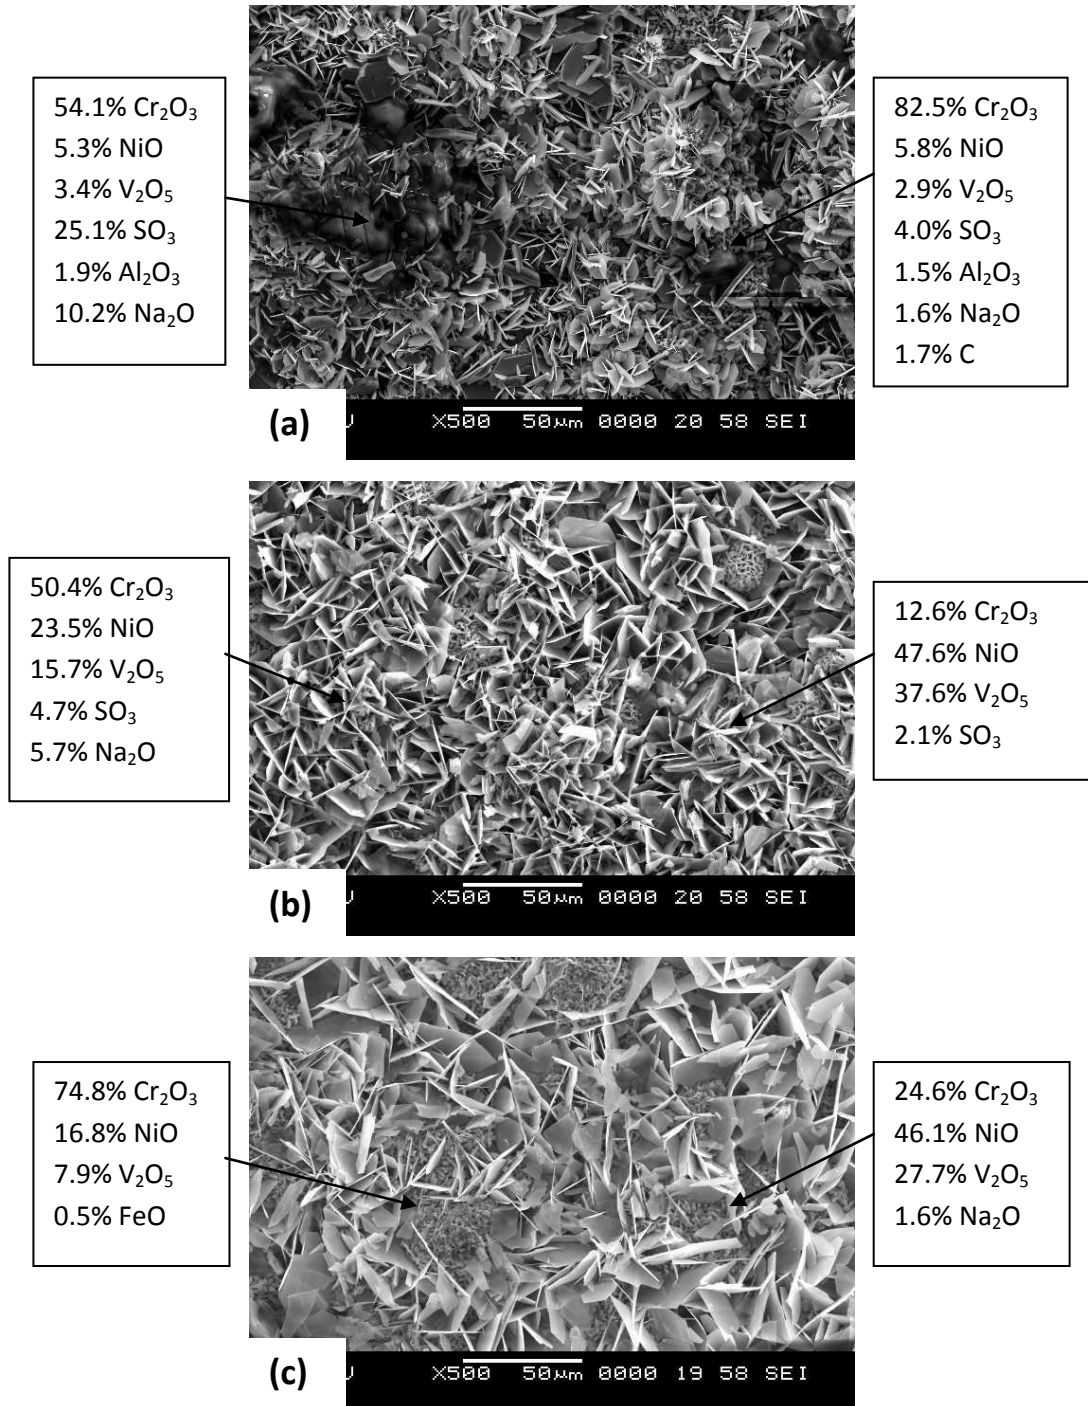
Fig. 5.14 SEM/EDX analysis for 25% (Cr₃C₂-25(Ni20Cr)) + 75%NiCrAlY coated samples subjected to hot corrosion for 50 cycles in Na₂SO₄+50% V₂O₅ at 800 ° C
