STUDIES ON THE ROLE OF HVOF COATINGS TO COMBAT HOT CORROSION, OXIDATION AND EROSION OF MATERIALS USED IN TURBINE COMPONENTS

Thesis

**DEPARTMENT OF METALLURGICAL AND MATERIALS
ENGINEERING**

**NATIONAL INSTITUTE OF TECHNOLOGY KARNATAKA,
SURATHKAL, MANGALORE – 575025**

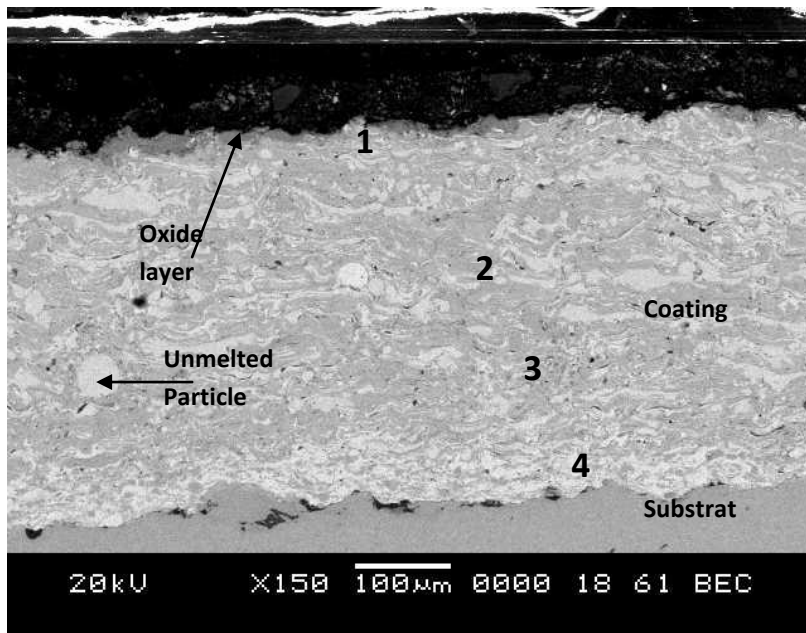
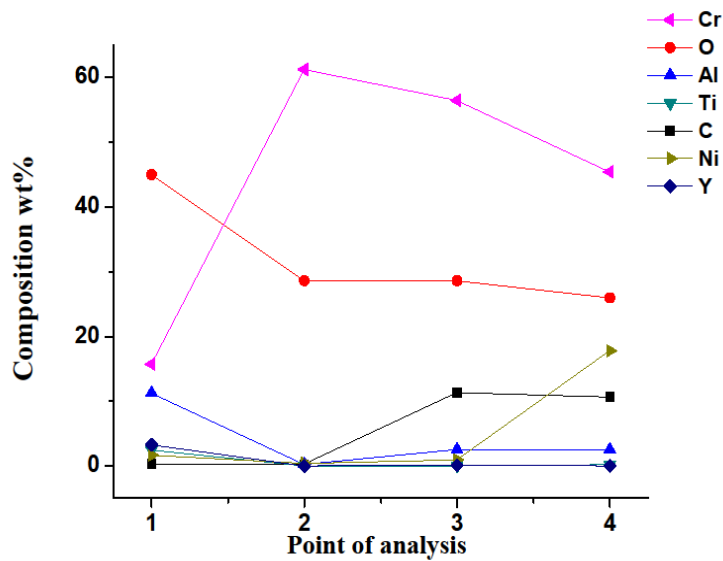
Fig. 5.15 Back scattered image and EDX analysis of the cross-section of the 25% (Cr_3C_2 -25(Ni20Cr)) + 75%NiCrAlY coated Ti-31 material subjected to hot corrosion for 50 cycles in Na_2SO_4 +50% V_2O_5 at 800 °C.

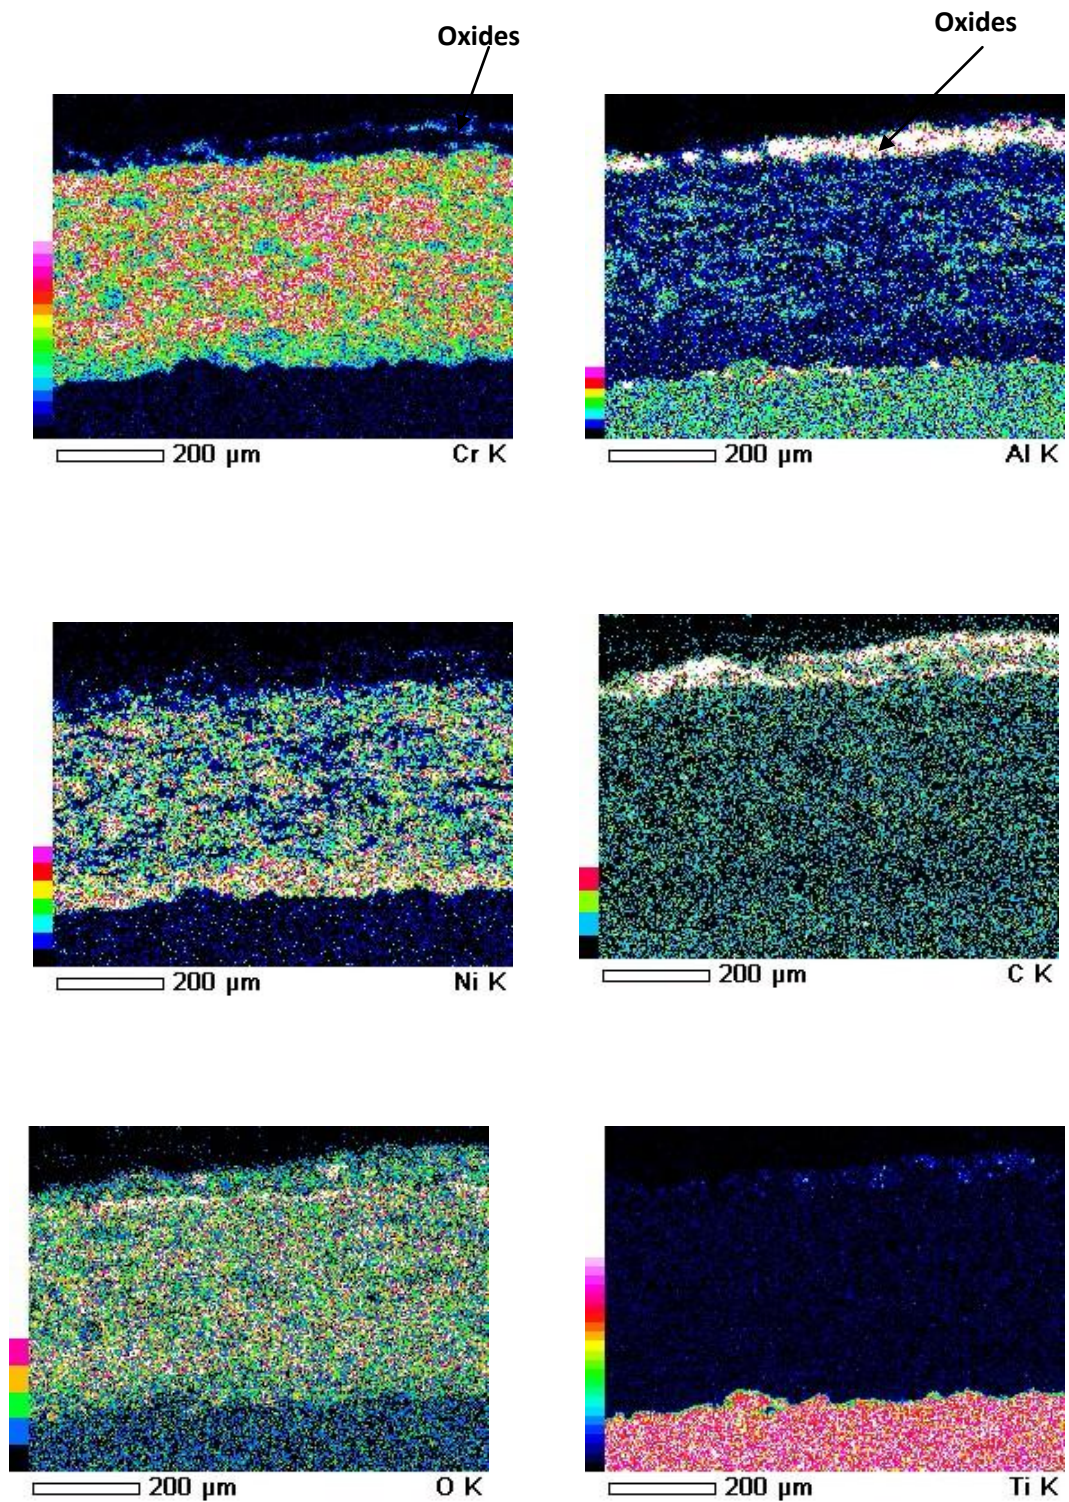
Fig. 5.16 X-ray mapping along the cross-section of the 25% (Cr_3C_2 -25(Ni20Cr)) + 75%NiCrAlY coated Ti-31 material subjected to hot corrosion for 50 cycles in Na_2SO_4 +50% V_2O_5 environment at 800 °C.

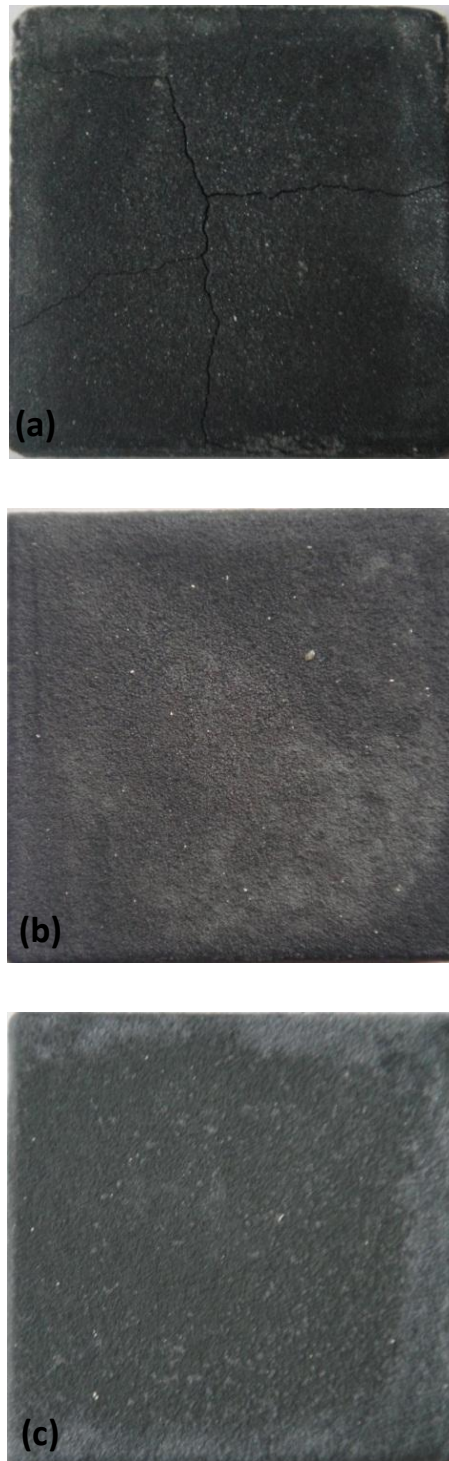
Fig. 5.17 Macrographs of Stellite-6 coated substrates subjected to hot corrosion in Na_2SO_4 -50% V_2O_5 environment at 800 °C for 50 cycles (a) Ti-31 substrate (b) Superco-605 substrate (c) MDN-121 substrate.

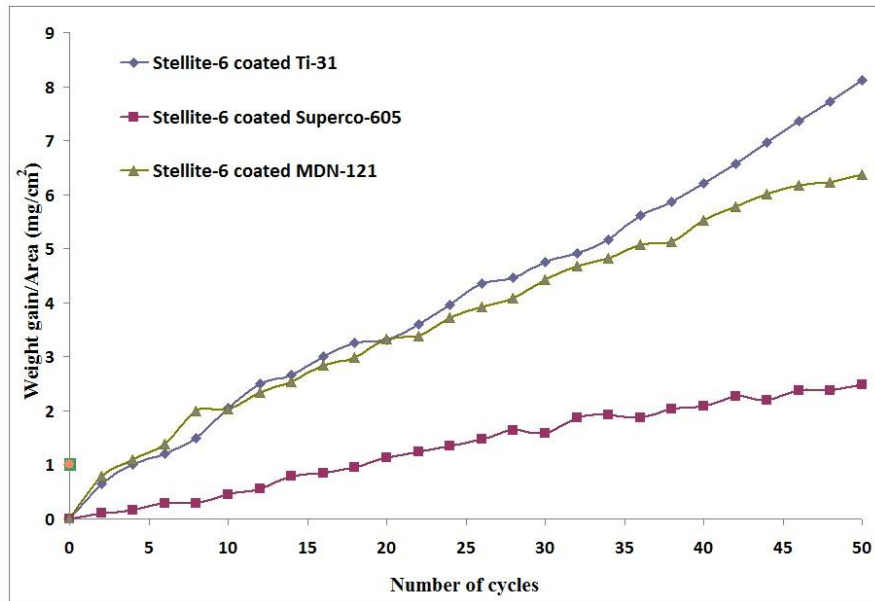
Fig. 5.18 Plot of weight gain/area versus number of cycles for Stellite-6 coated samples subjected to hot corrosion.

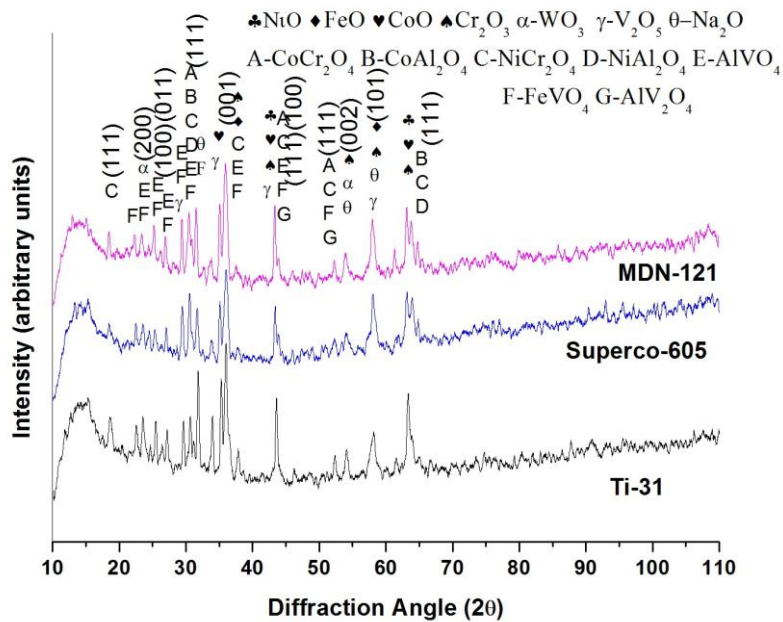
Fig. 5.19 X-ray diffraction patterns for Stellite-6 coated Ti-31, Superco-605 and MDN-121 subjected to hot corrosion in Na₂SO₄-50%V₂O₅ for 50 cycles at 800 °C.

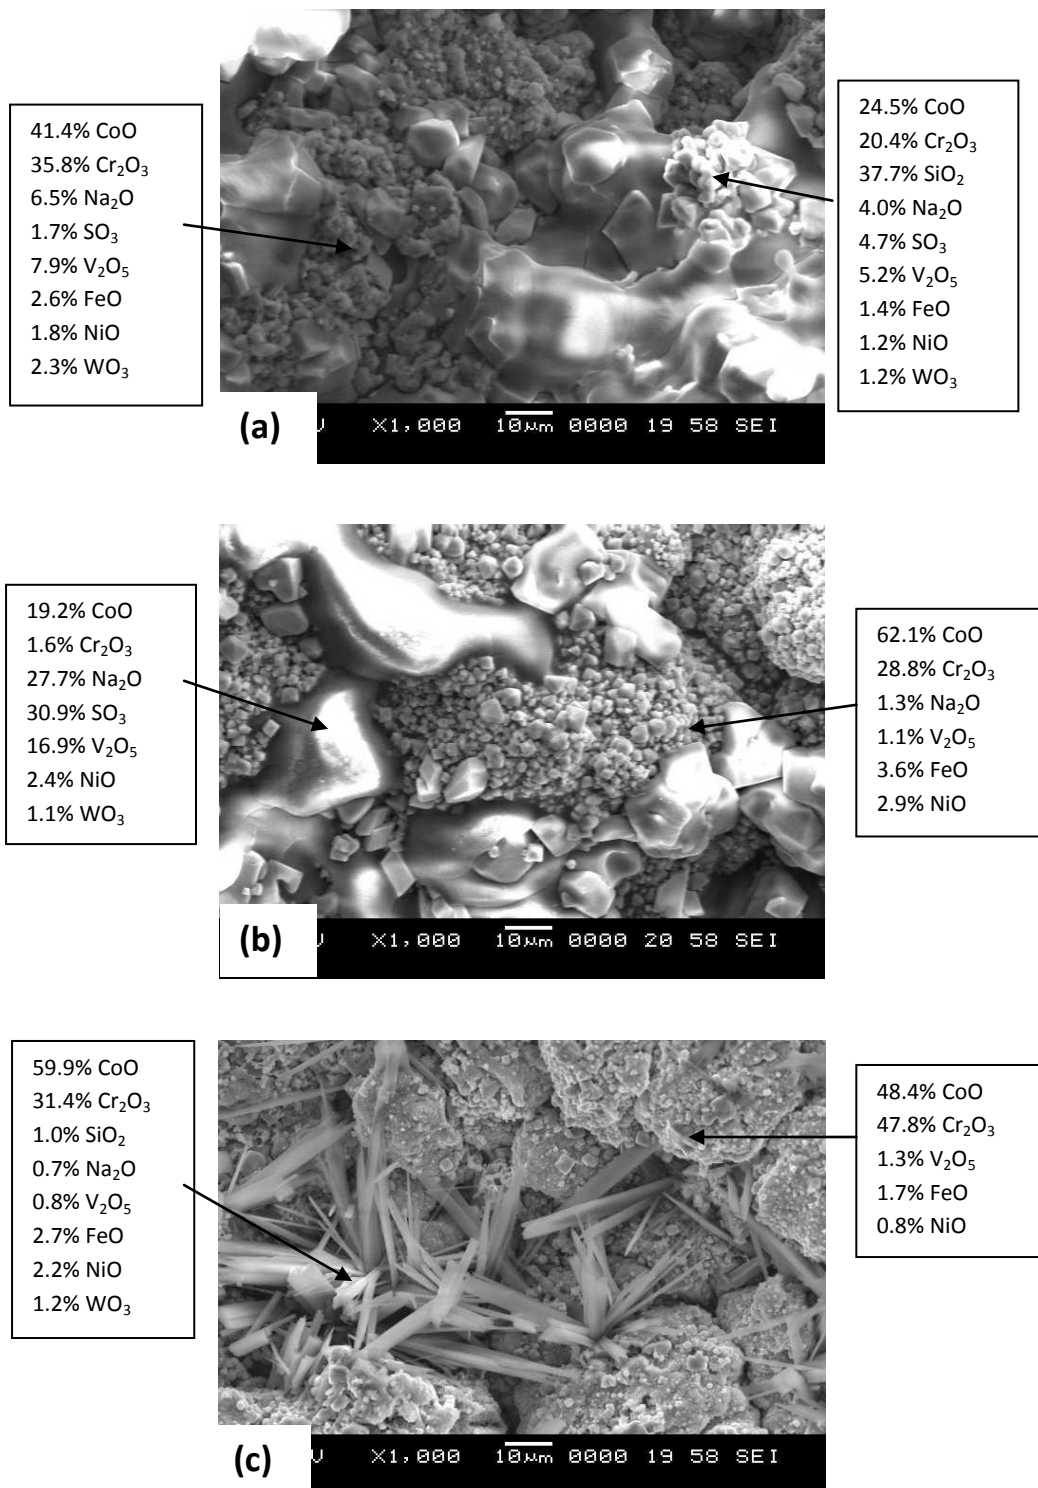
Fig. 5.20 SEM/EDX analysis of Stellite-6 coated samples subjected to hot corrosion for 50 cycles in Na₂SO₄+50%V₂O₅ at 800 °C (a) Ti-31 (b) Superco-605 (c) MDN- 121.

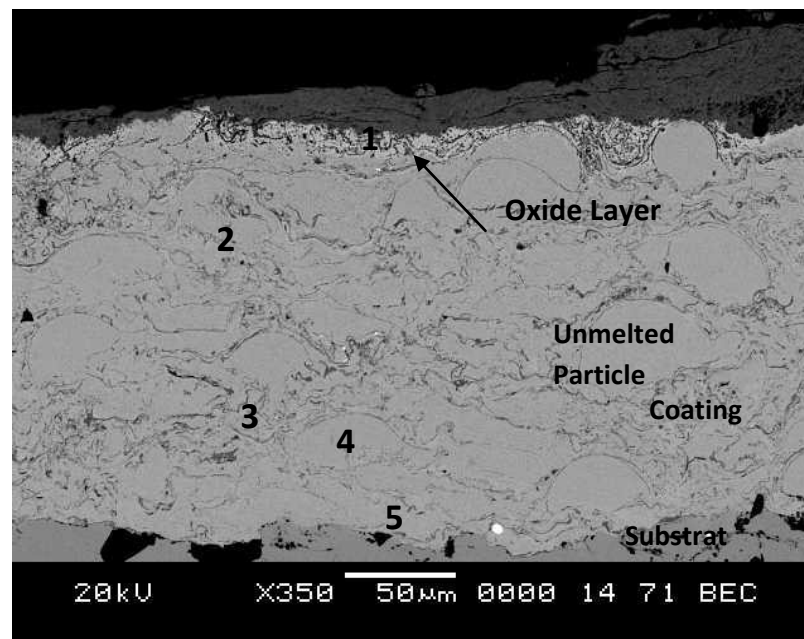
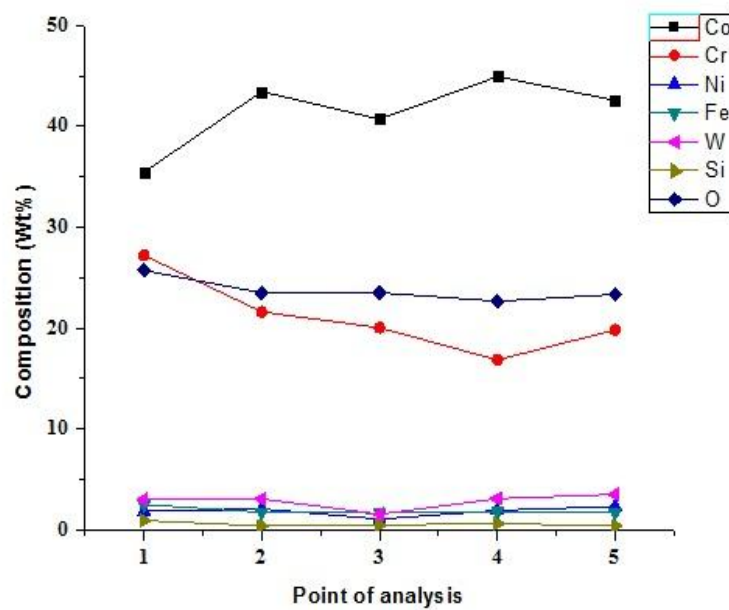
Fig. 5.21 Back scattered image and EDX analysis across the cross-section of the Stellite-6 coated MDN-121 material subjected to hot corrosion for 50 cycles in $\text{Na}_2\text{SO}_4+50\% \text{V}_2\text{O}_5$ at 800 °C.

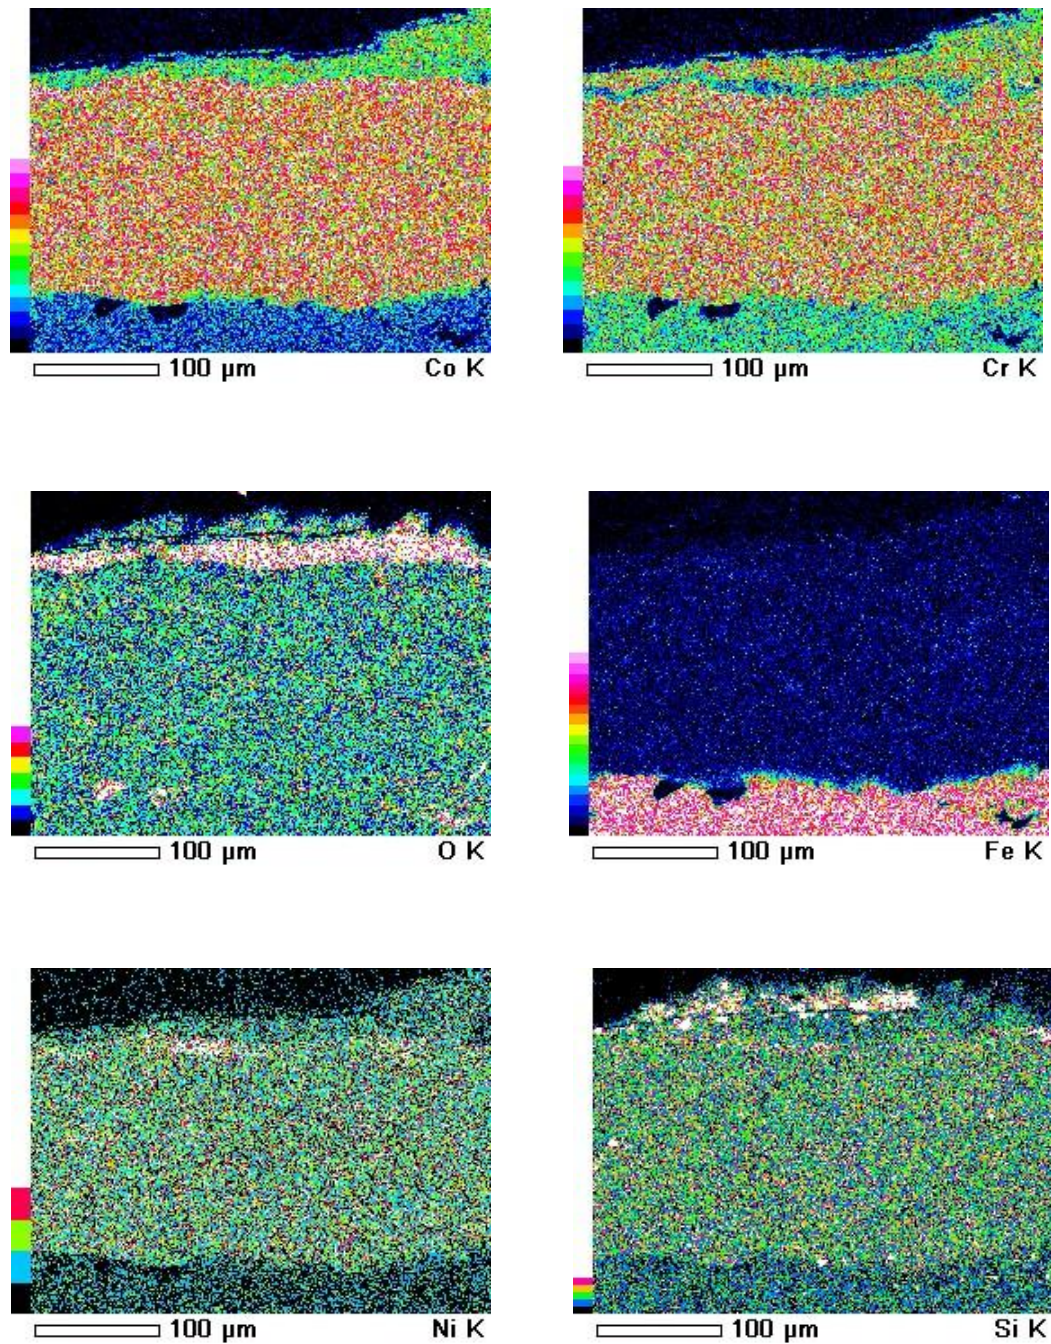
Fig. 5.22 X-ray maps along the cross-section of the Stellite-6 coated MDN-121 material subjected to hot corrosion for 50 cycles in $\text{Na}_2\text{SO}_4+50\%\text{V}_2\text{O}_5$ environment at 800 °C.

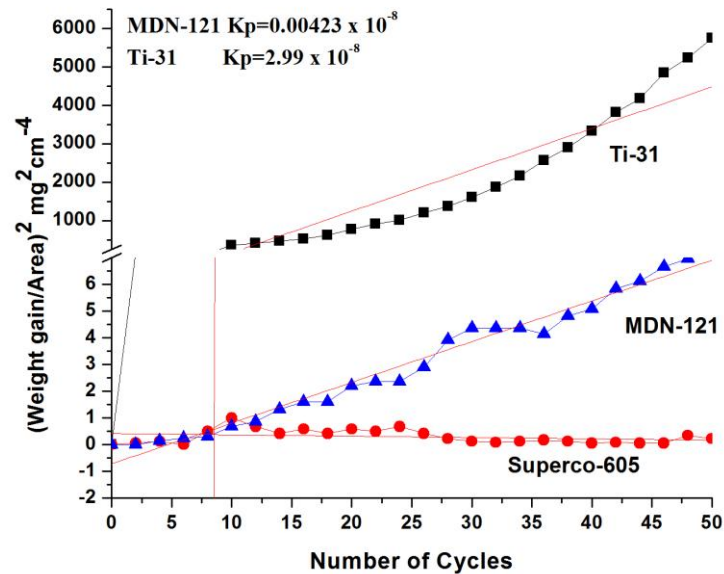
Fig. 5.23 Graph of $(\text{weight gain/area})^2$ versus number of cycles for uncoated samples subjected to hot corrosion.

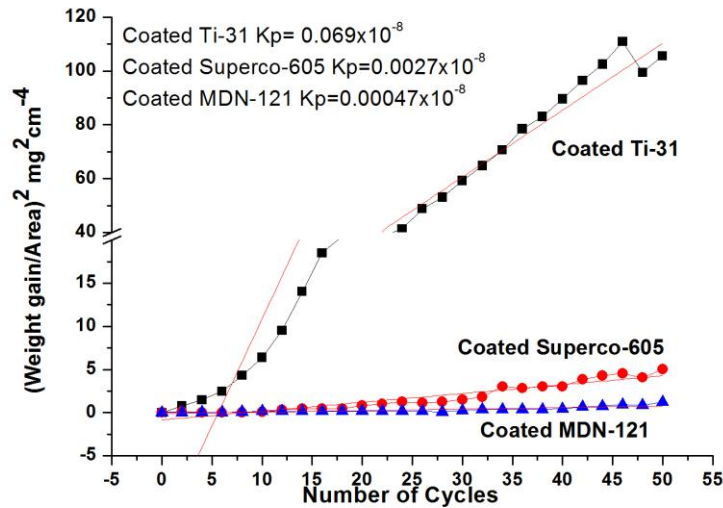
Fig. 5.24 Plot of (weight change/area) ² vs number of cycles for 10% Al₂O₃ + CoCrAlTaY coated materials subjected to hot corrosion in Na₂SO₄-50%V₂O₅ salt environment at 800 °C.

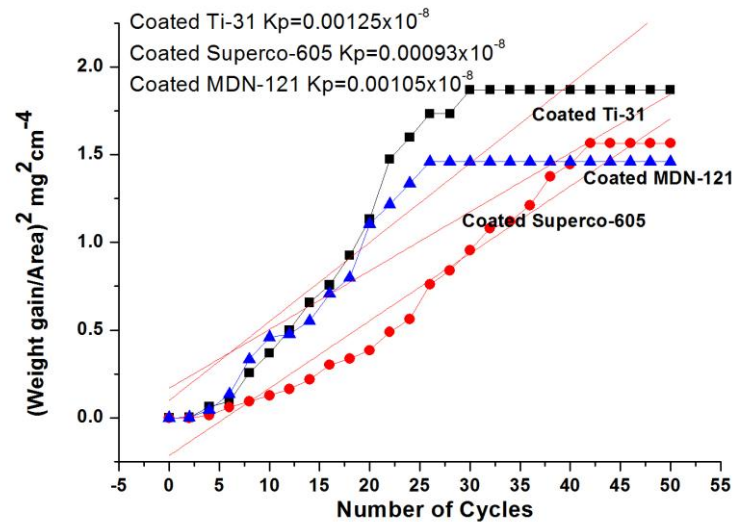
Fig. 5.25 Plot of $(\text{weight gain/area})^2$ versus number of cycles for 25% ($\text{Cr}_3\text{C}_2\text{-}25(\text{Ni}_{20}\text{Cr})$) + 75% NiCrAlY coated samples subjected to hot corrosion for 50 cycles.

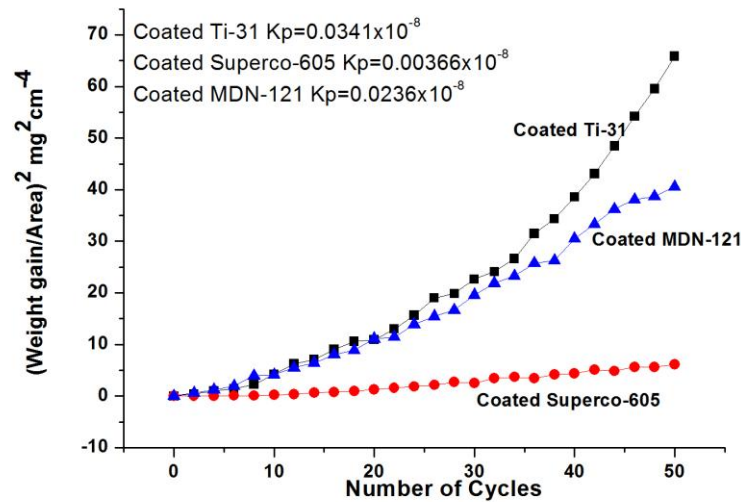
Fig. 5.26 Plot of $(\text{weight gain/area})^2$ versus number of cycles for Stellite-6 coated samples subjected to hot corrosion.

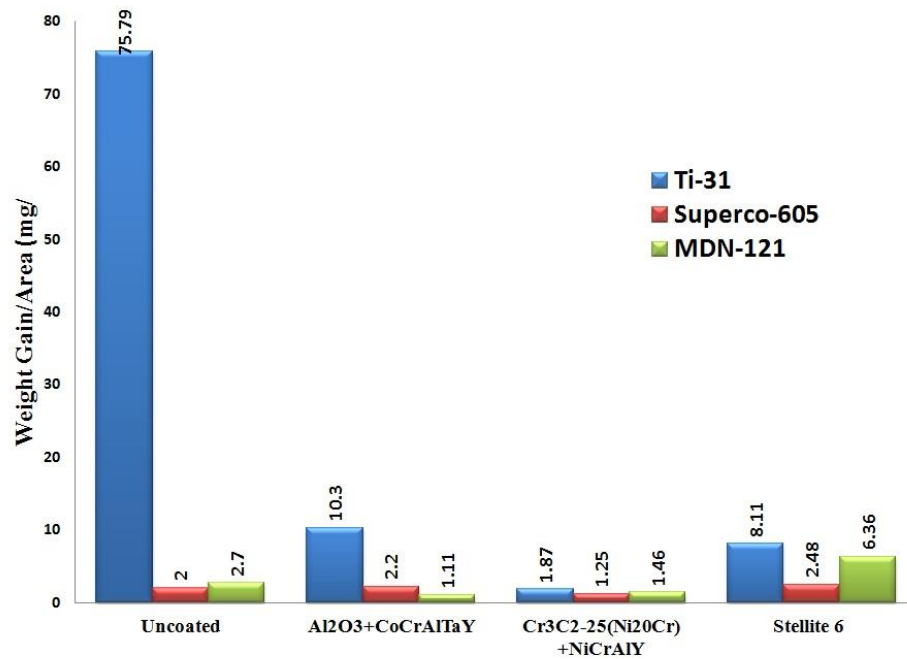
Fig. 5.27 Bar chart showing cumulative weight gain (mg/cm^2) for uncoated and HVOF coated samples subjected to hot corrosion in Na_2SO_4 -50% V_2O_5 salt environment for 50 cycles at 800 °C.

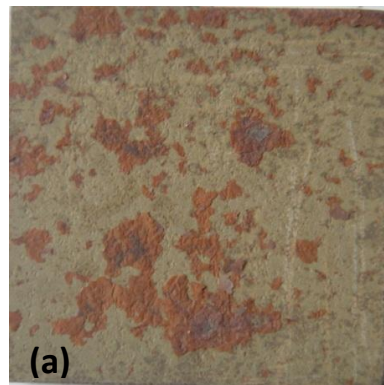
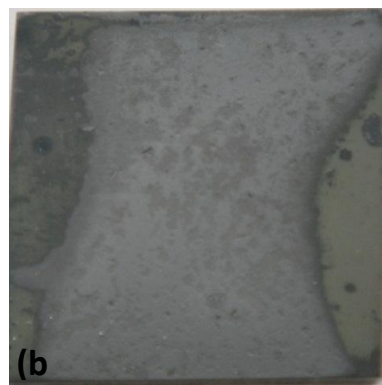
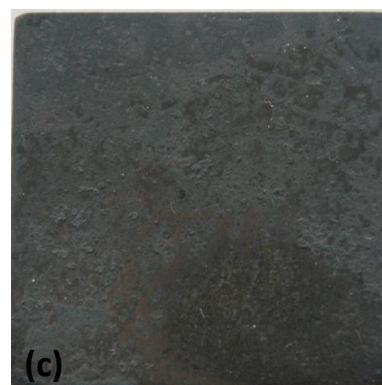
Fig. 6.1 Macrographs of substrate materials subjected to cyclic oxidation in air at 800 °C for 50 cycles: Size 25 X 25 X 5 mm (a) Ti-31 (b) Superco-605 (c) MDN-121.

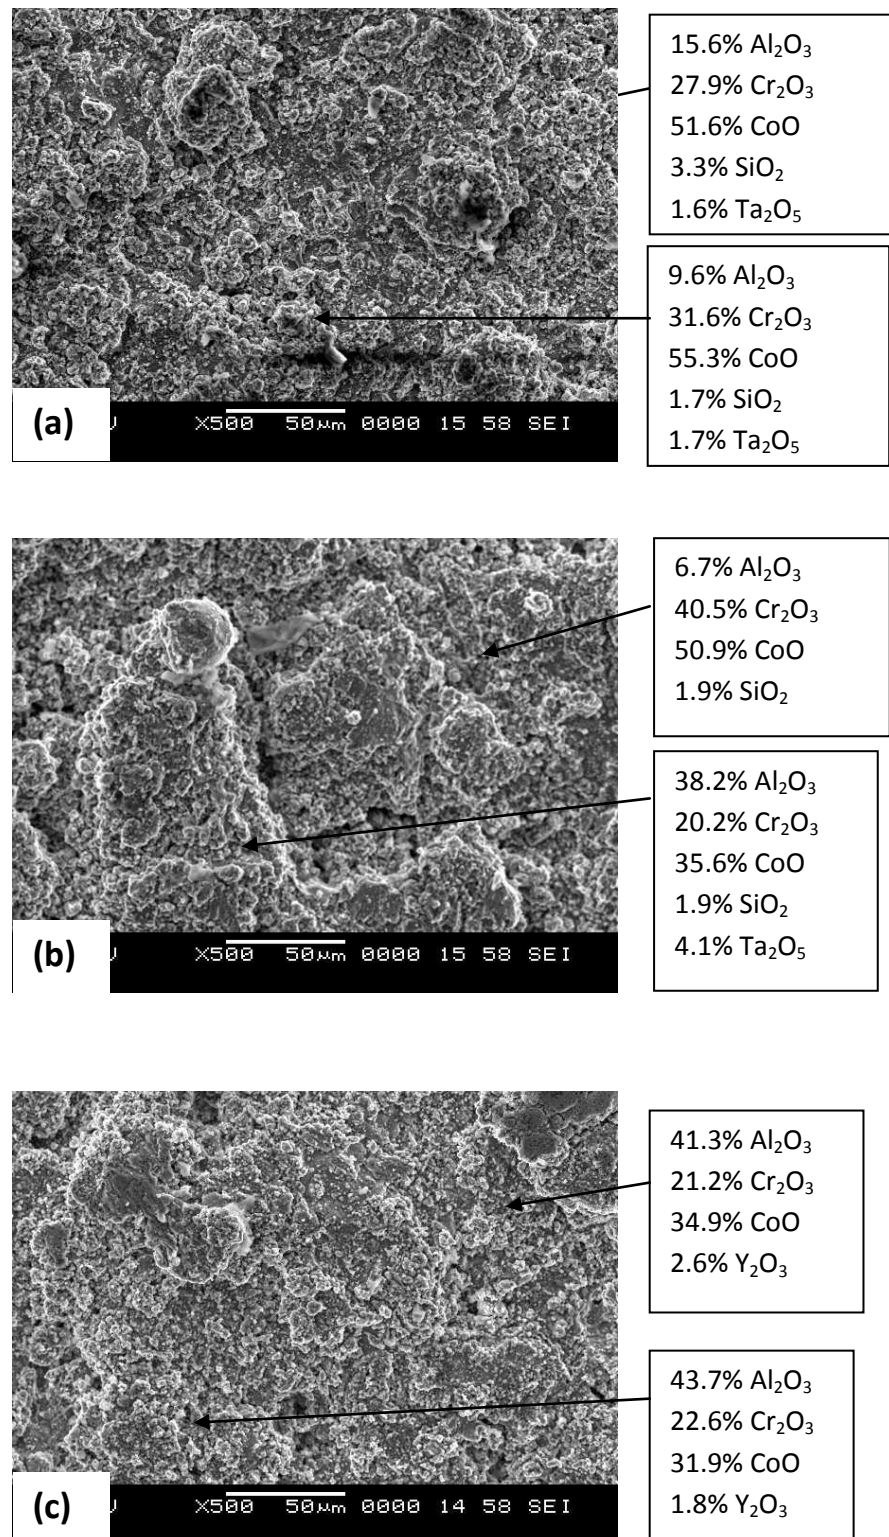
Fig. 6.8 Morphology of scales and EDX analysis for the 10% Al₂O₃+CoCrAlTaY coated samples subjected to cyclic oxidation in air at 800 °C for 50 cycles
(a) Ti-31 substrate (b) Superco-605 substrate (c) MDN-121 substrate.

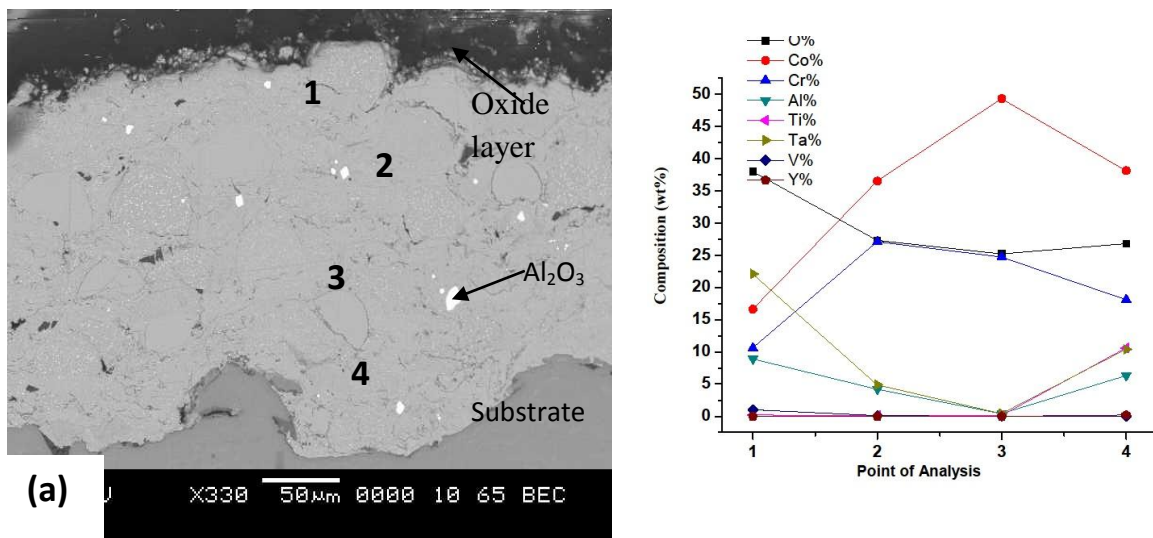
Fig. 6.9 Back scattered image and EDX analysis across the cross-section of the 10% Al₂O₃ + CoCrAlTaY coated Ti-31 material subjected to oxidation for 50 cycles at 800 °C

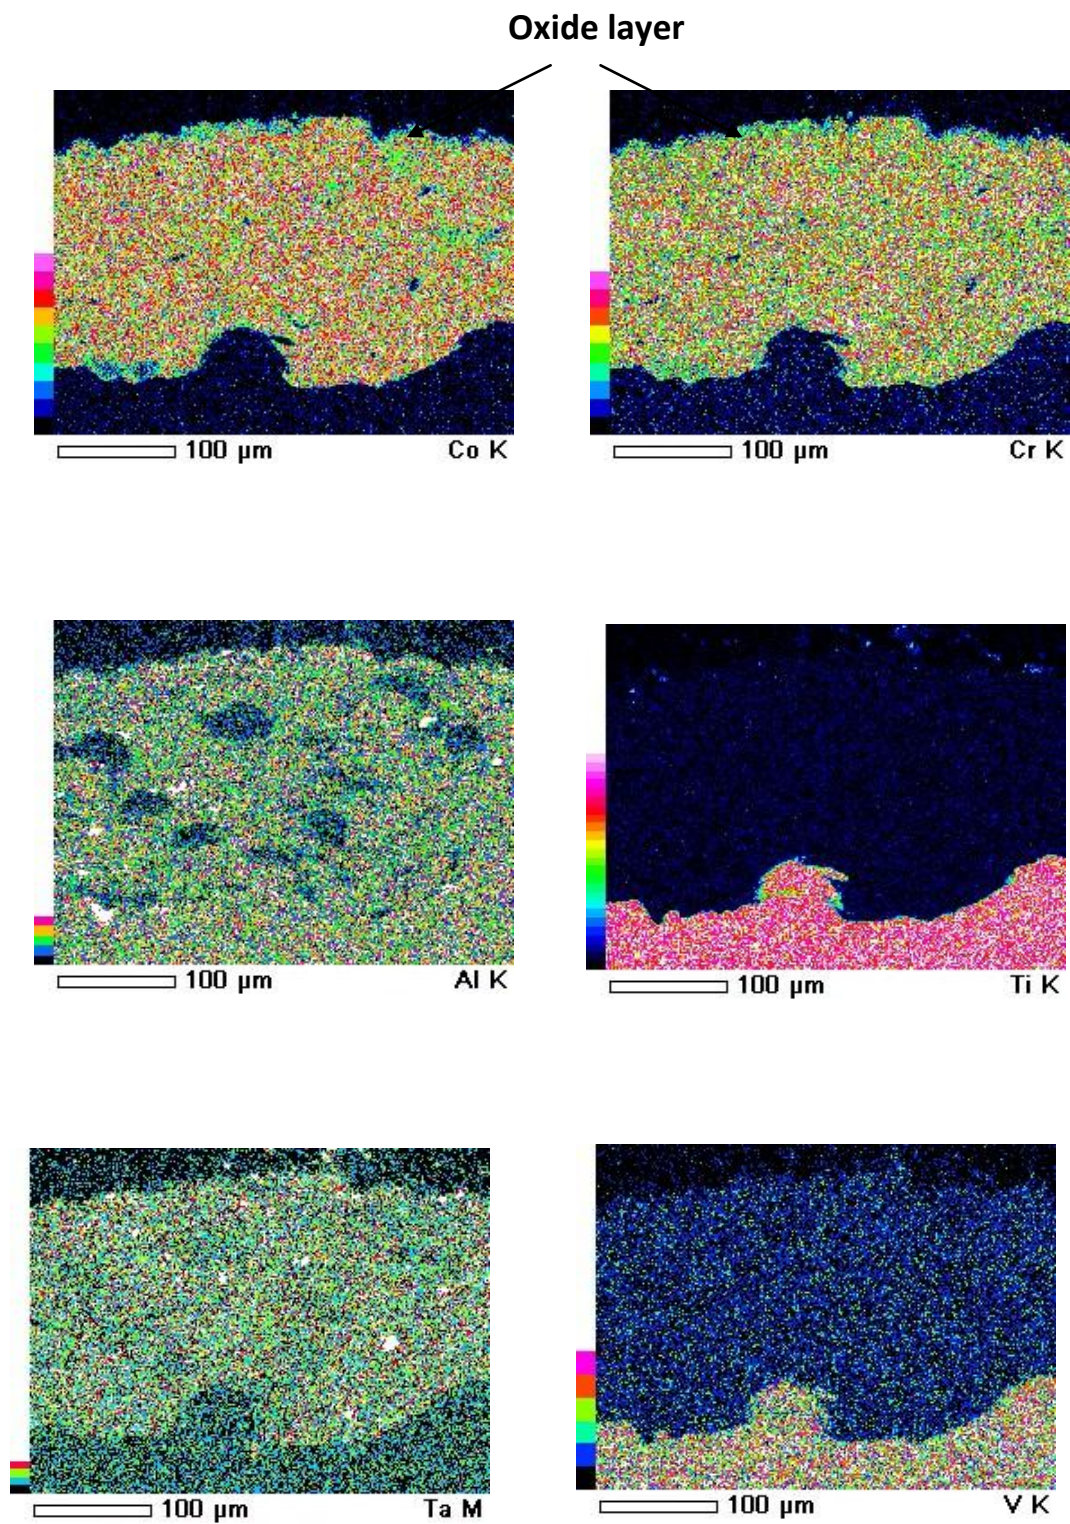
Fig. 6.10 X-ray mapping along the cross-section of the 10% Al_2O_3 +CoCrAlTaY coated Ti-31 material subjected to oxidation for 50 cycles at 800 °C.

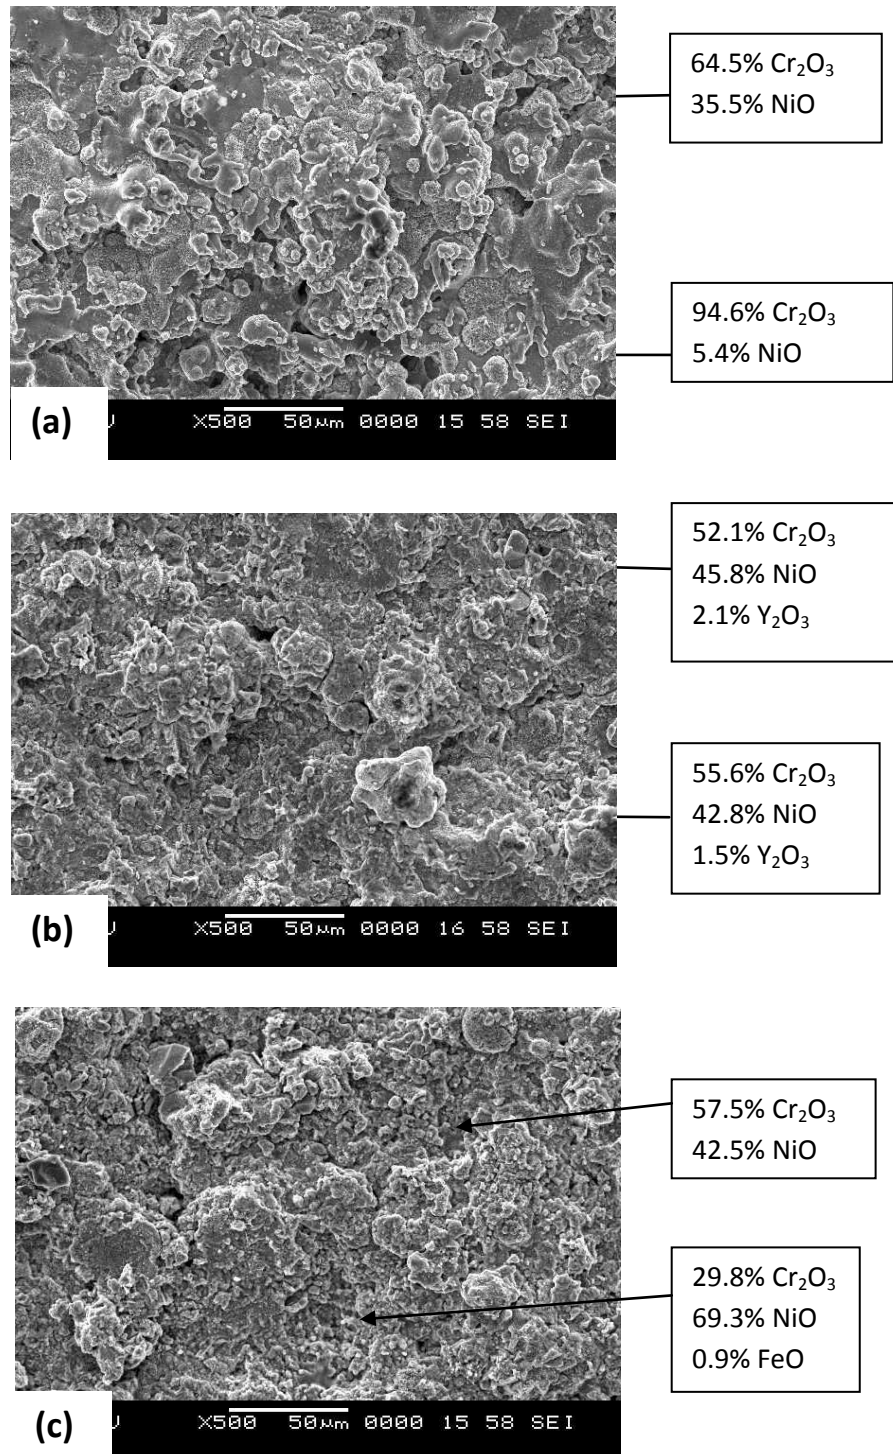
**Fig. 6.14 Morphology of scales and EDX analysis for 25% (Cr_3C_2 -25(Ni_{20}Cr)) + 75% NiCrAlY coated samples subjected to oxidation for 50 cycles at 800 °C
(a) Ti-31 substrate (b) Superco-605 substrate (c) MDN-121 substrate.**

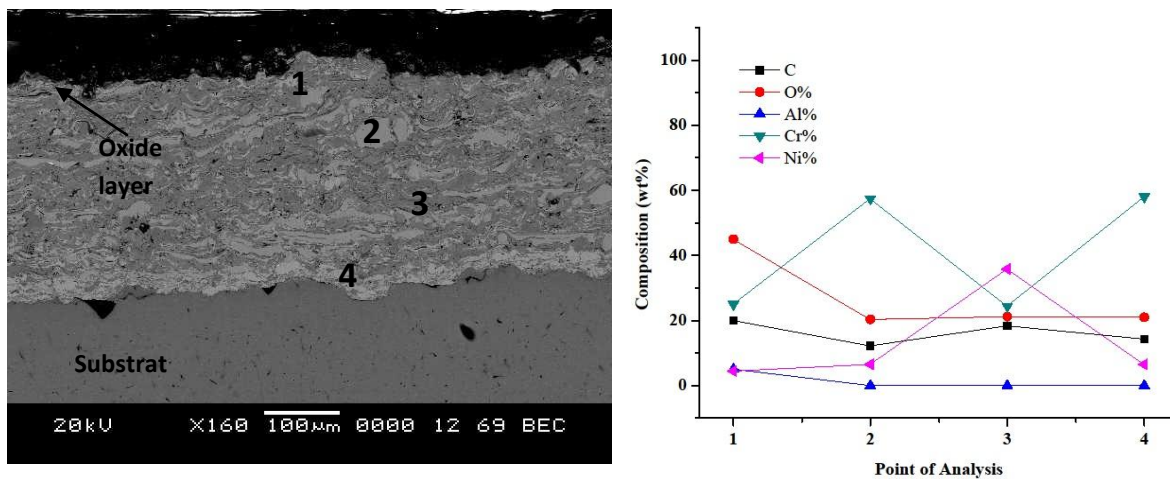
Fig. 6.15 Back scattered image and EDX analysis (wt %) across the cross-section of the 25% (Cr₃C₂-25(Ni20Cr)) + 75% NiCrAlY coated Ti-31 material subjected to oxidation for 50 cycles at 800 °C.

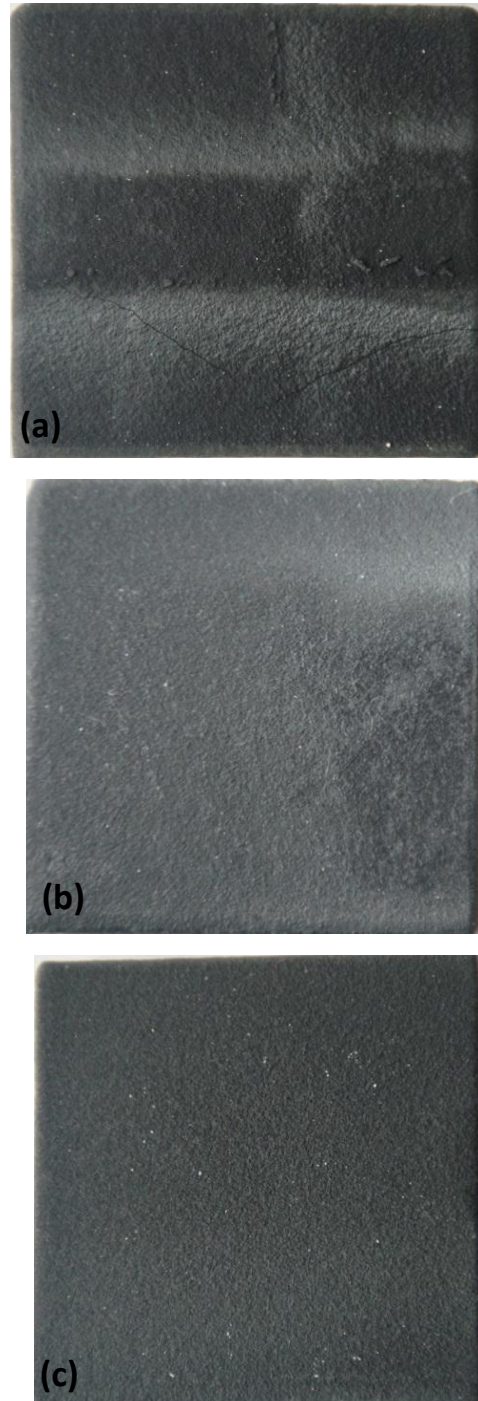
Fig. 6.17 Macrographs of Stellite-6 coating subjected to oxidation at 800 °C for 50 cycles. Size 25 X 25 X 5 mm (a) Ti-31 substrate (b) Superco-605 substrate (c) MDN-121 substrate.

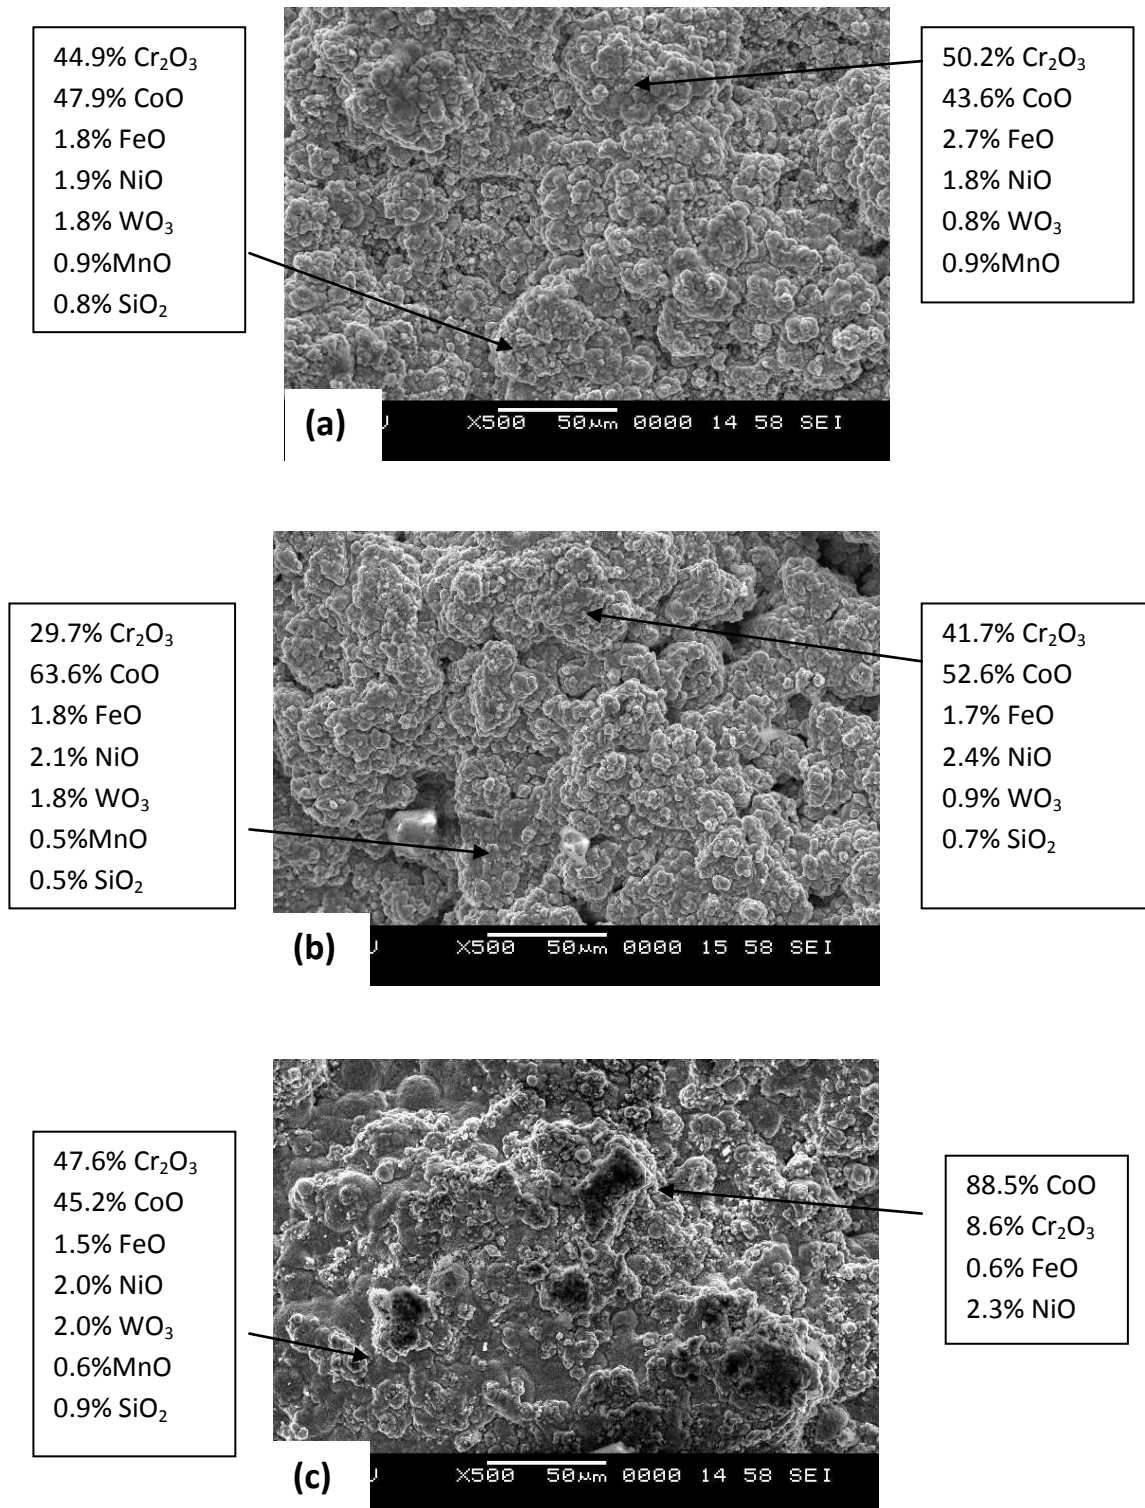
Fig. 6.20 Morphologies and EDX analysis of the Stellite-6 coated samples after oxidation for 50 cycles at 800 °C. (a) Ti-31 substrate (b) Superco-605 substrate (c) MDN-121 substrate.

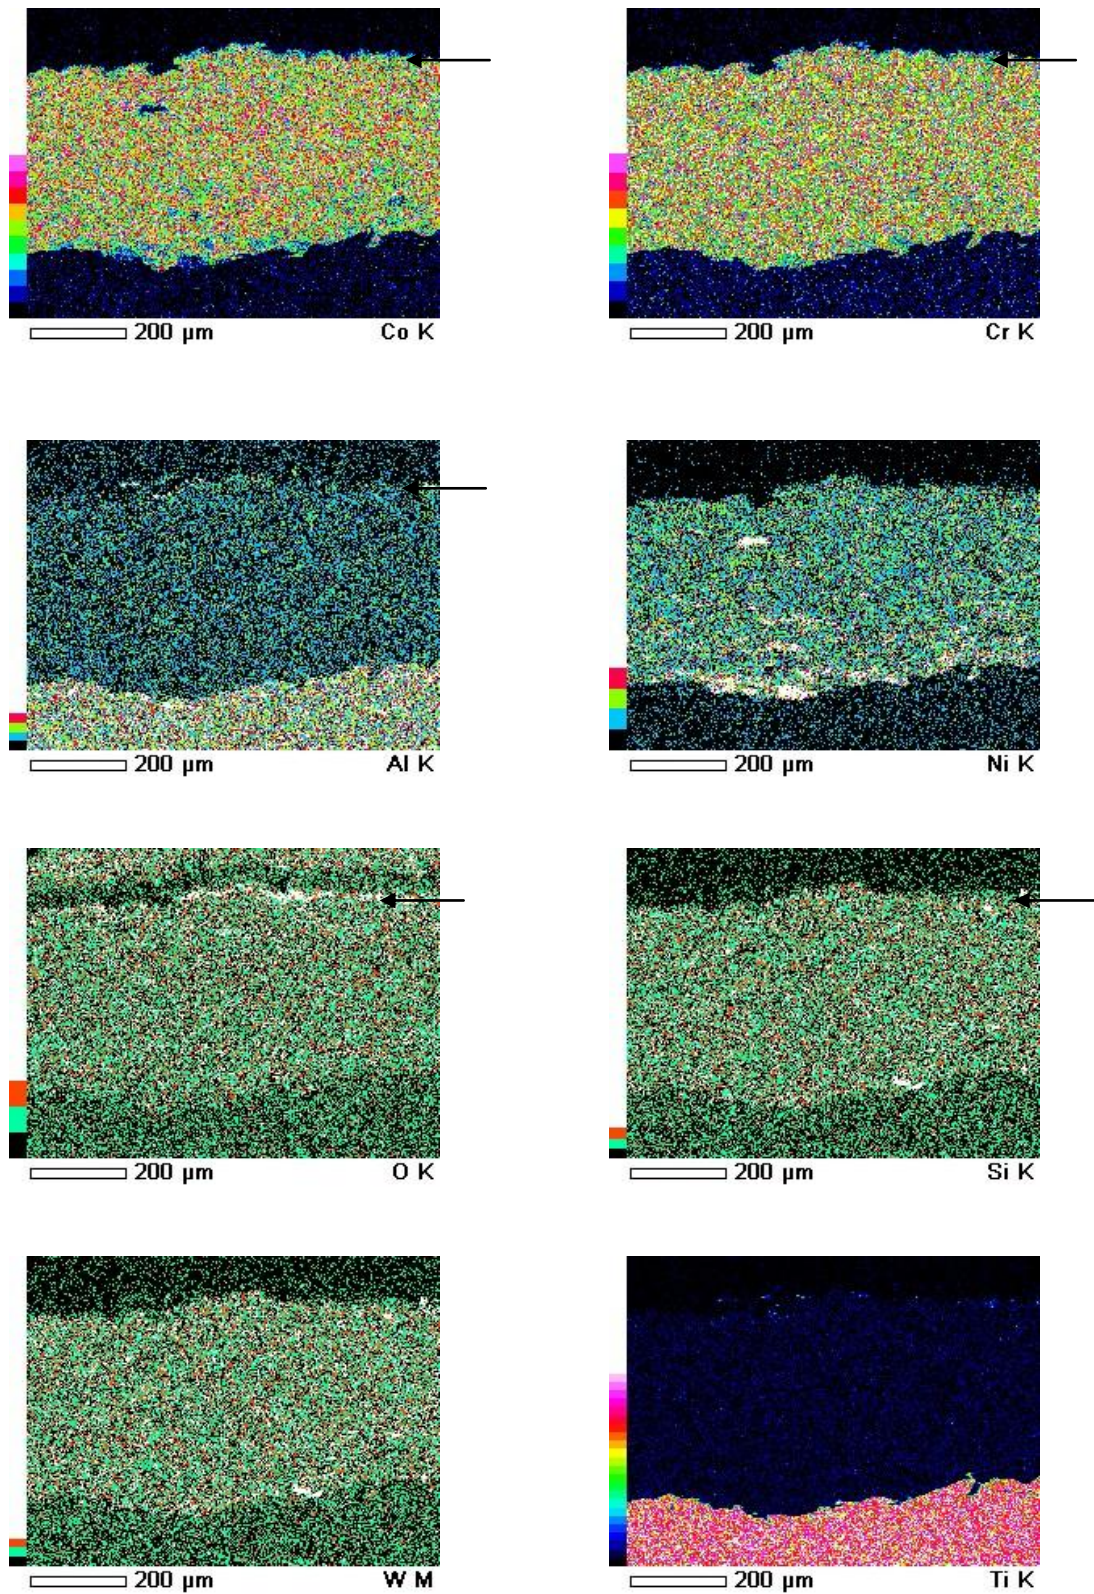
Fig. 6.22 X-ray mapping along the cross-section of the Stellite-6 coated Ti-31 material subjected to oxidation for 50 cycles at 800 °C.

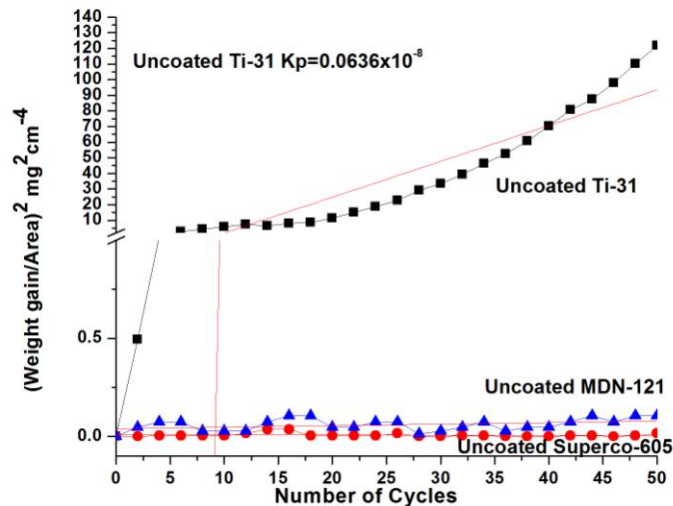
Fig. 6.23 Plot of $(\text{weight gain/area})^2$ versus number of cycles for uncoated samples subjected to oxidation for 50 cycles in air at 800 °C.

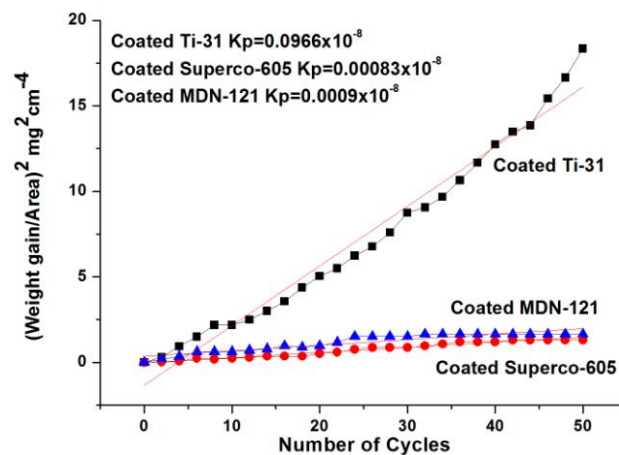
Fig. 6.24 Plot of $(weight\ gain/area)^2$ versus number of cycles for 10% $Al_2O_3 + CoCrAlTaY$ coated materials subjected to oxidation in air at 800 °C.

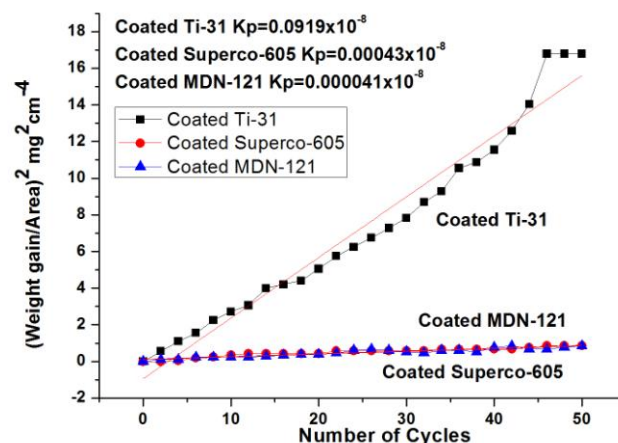
Fig. 6.26 Plot of $(\text{weight gain/area})^2$ versus number of cycles for Stellite-6 coated samples subjected to oxidation at 800°C .

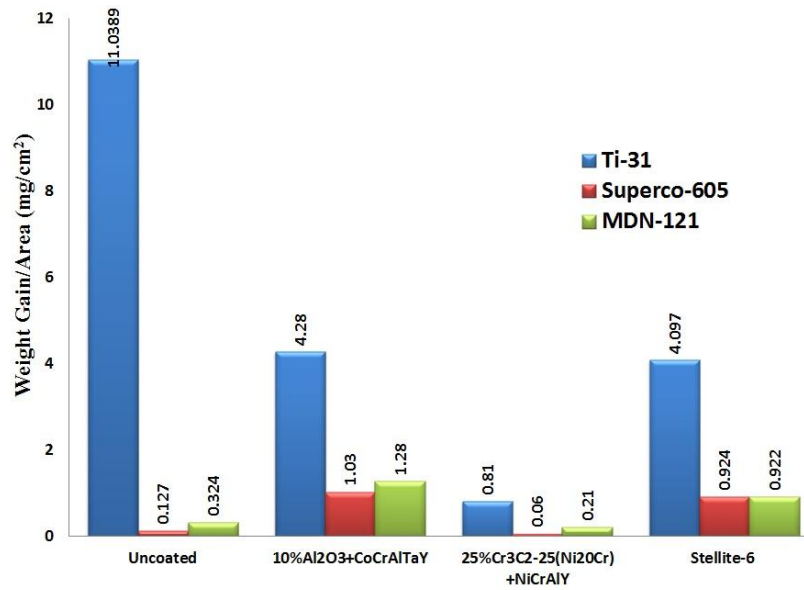
Fig. 6.27 Bar chart showing cumulative weight gain (mg/cm^2) for uncoated and HVOF coated samples subjected to oxidation in air environment for 50 cycles at $800\text{ }^\circ\text{C}$.
