STUDIES ON THE ROLE OF HVOF COATINGS TO COMBAT HOT CORROSION, OXIDATION AND EROSION OF MATERIALS USED IN TURBINE COMPONENTS

Thesis

**DEPARTMENT OF METALLURGICAL AND MATERIALS
ENGINEERING**

**NATIONAL INSTITUTE OF TECHNOLOGY KARNATAKA,
SURATHKAL, MANGALORE – 575025**

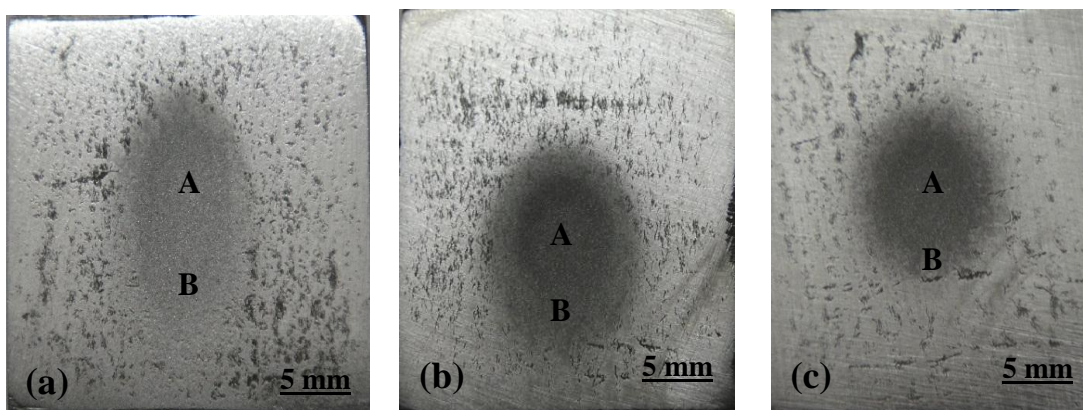
Fig. 7.1 Macrographs of uncoated Ti-31 alloy impacted by silica erodent at different angles. (a) Impact angle of 30° (b) Impact angle of 60° (c) Impact angle of 90° .

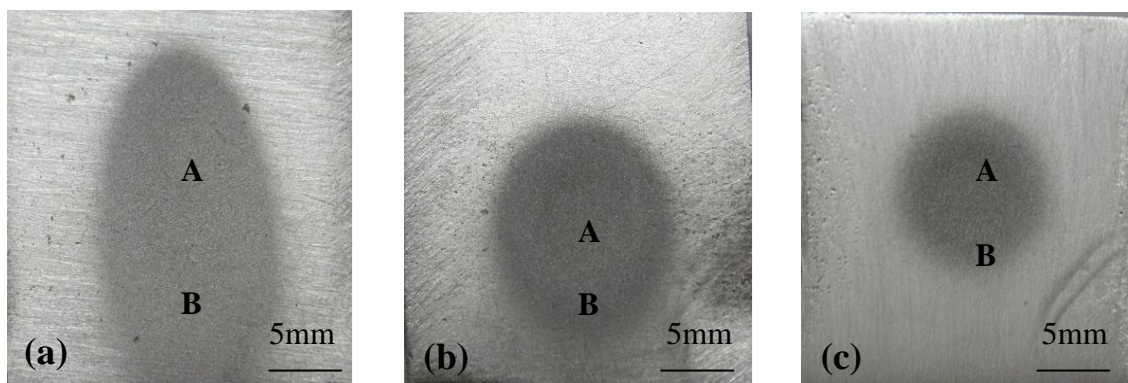
Fig. 7.6 Macrographs of uncoated Superco-605 superalloy impacted by silica erodent at different angles. (a) Impact angle of 30° (b) Impact angle of 60° c) Impact angle of 90°.

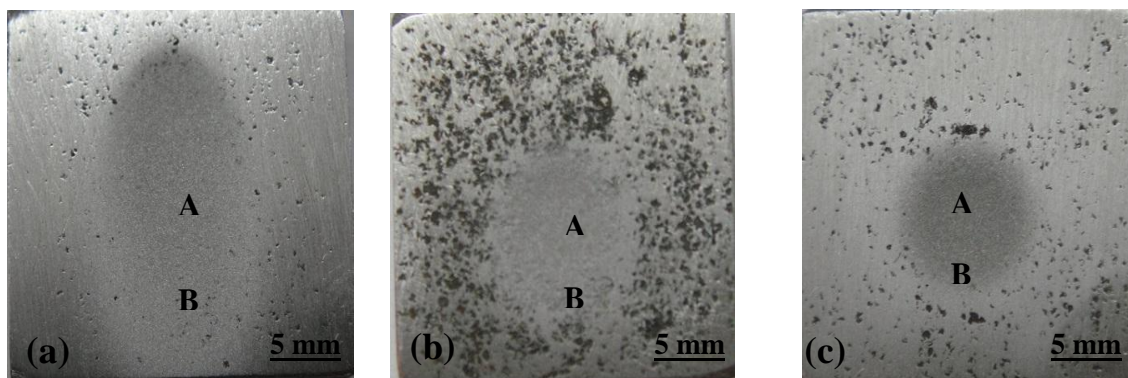
Fig. 7.11 Macrographs of uncoated MDN-121 impacted by silica erodent at different angles. (a) Impact angle of 30° (b) Impact angle of 60° c) Impact angle of 90° .

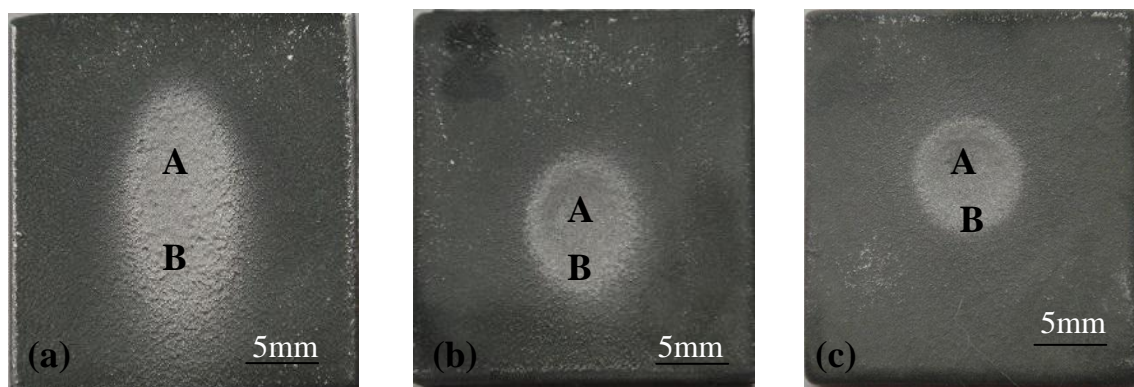
Fig. 7.16 Macrographs of 10% Al_2O_3 +CoCrAlTaY coated Ti-31 impacted by silica erodent at different angles. (a) Impact angle 30° (b) Impact angle 60° (c) Impact angle 90° .

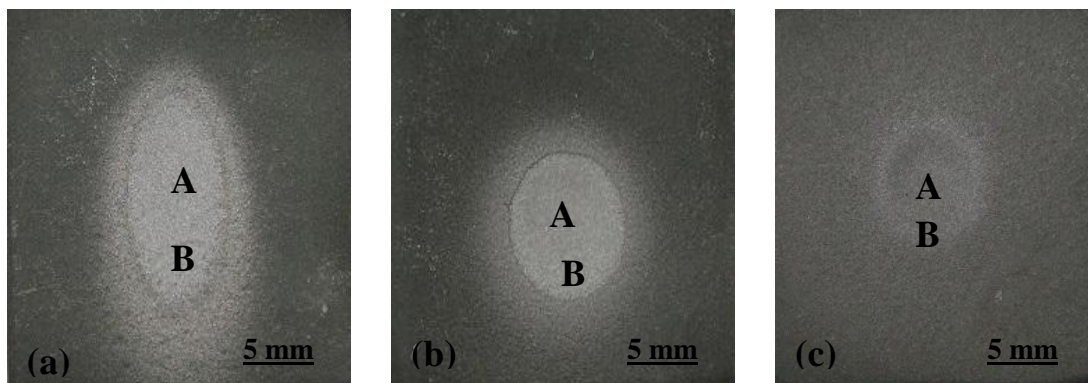
Fig. 7.21 Macrographs of 25% (Cr_3C_2 -25(Ni20Cr)) + 75%NiCrAlY coated Ti-31 impacted by silica erodent at different angles. (a) Impact angle of 30° (b) Impact angle of 60° (c) Impact angle of 90°.

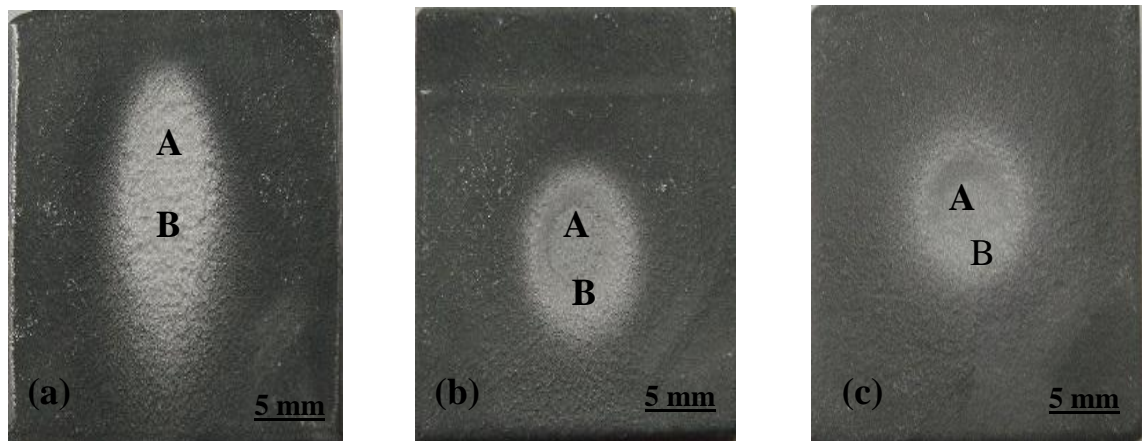
Fig. 7.26 Macrographs of Stellite-6 coated Ti-31 impacted by silica erodent at different angles. (a) Impact angle of 30° (b) Impact angle of 60° (c) Impact angle of 90° .

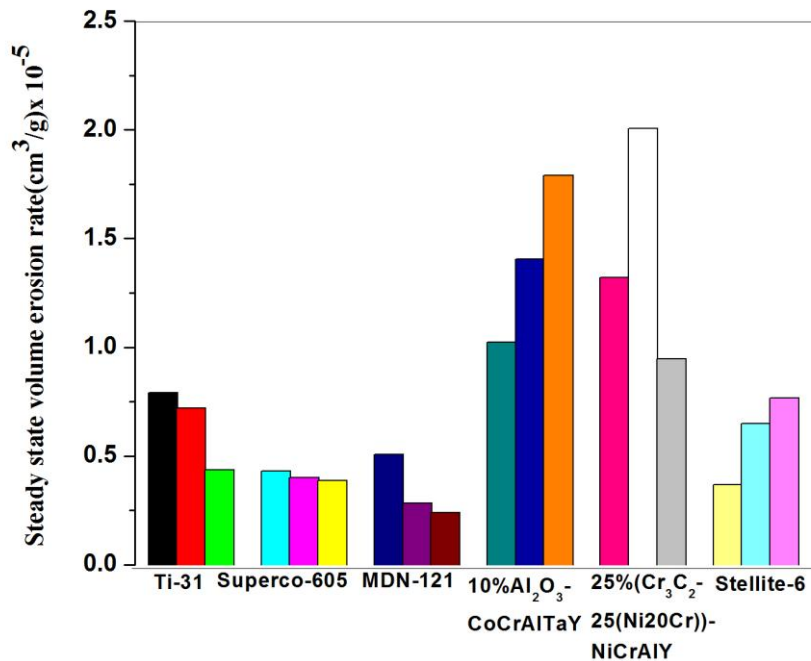
Fig. 7.31 Bar chart indicating volumetric steady state erosion rate for uncoated Ti-31, Superco-605, MDN-121 and HVOF coated Ti-31 alloy at 30°, 60° and 90° impact angle.

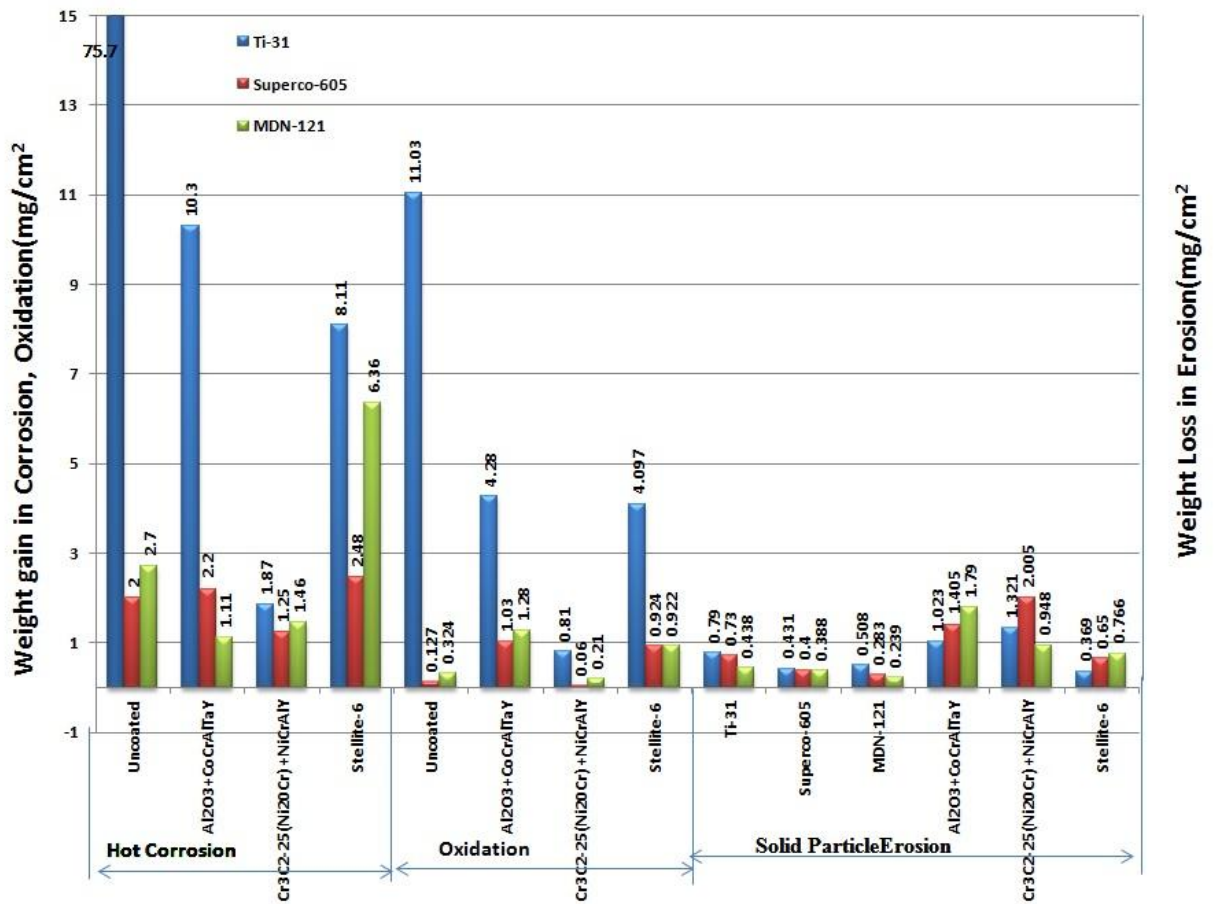
Fig. 8.1 Plot of comparison of cumulative damage due to hot corrosion, oxidation and solid particle erosion.
